LM6-208 - V.3.2

Borescope Inspection Report

Ponca City Municipal Steam Plant

Unit 3

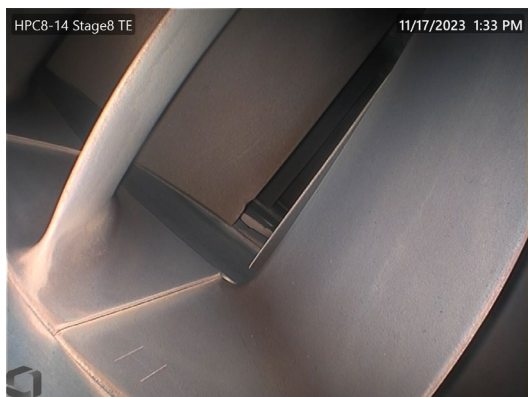
HPC8-14_Stage8_TE_001.JPG

Section	HPC8-14
Stage	Stage8
Component	TE
Defect	DENT
Comments

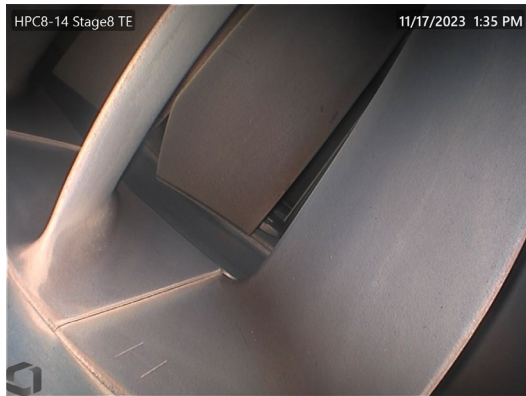
HPC8-14_Stage8_TE_002.JPG

Section	HPC8-14
Stage	Stage8
Component	TE
Defect	DENT
Comments

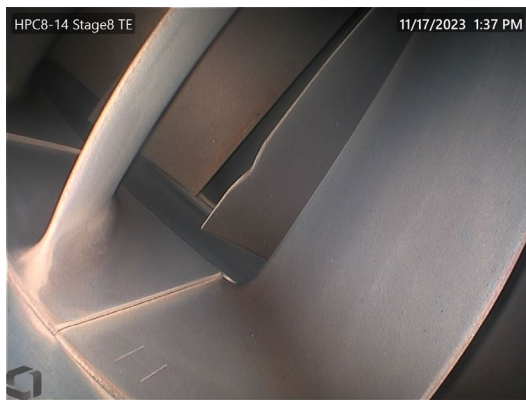
HPC8-14_Stage8_TE_003.JPG

Section	HPC8-14
Stage	Stage8
Component	TE
Defect	TEAR
Comments

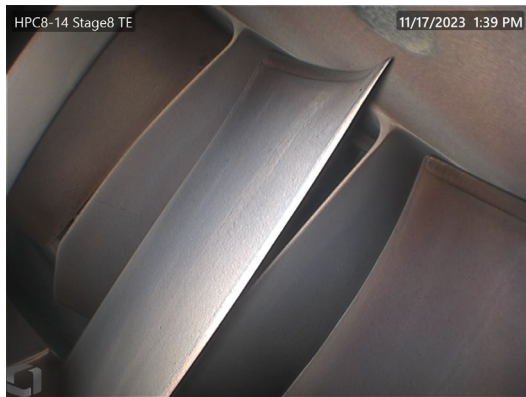
HPC8-14_Stage8_TE_004.JPG

Section	HPC8-14
Stage	Stage8
Component	TE
Defect	DENT
Comments

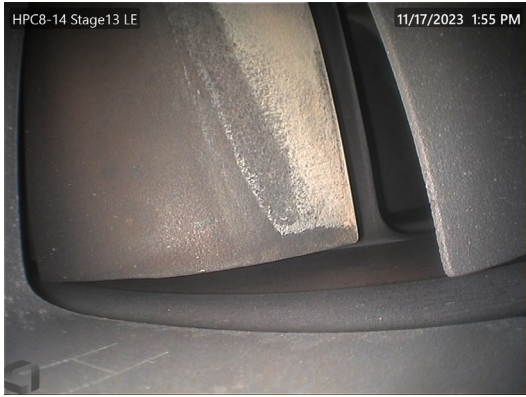
HPC8-14_Stage13_LE_001.JPG

Section	HPC8-14
Stage	Stage13
Component	LE
Defect	DENT
Comments

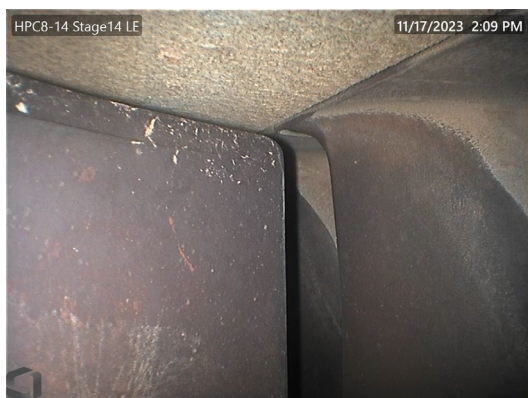
HPC8-14_Stage14_LE_001.JPG

Section	HPC8-14
Stage	Stage14
Component	LE
Defect	DENT
Comments

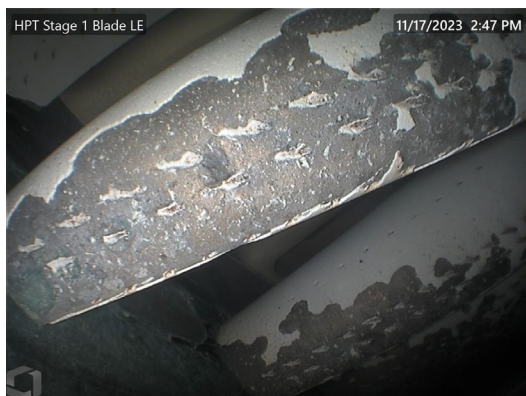
HPT_Stage_1_Blade_LE_001.JPG

Section	HPT
Stage	Stage 1 Blade
Component	LE
Defect	EROSION
Comments

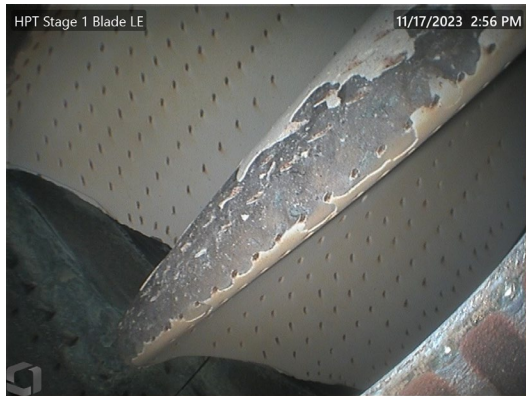
HPT_Stage_1_Blade_LE_002.JPG

Section	HPT
Stage	Stage 1 Blade
Component	LE
Defect	EROSION
Comments

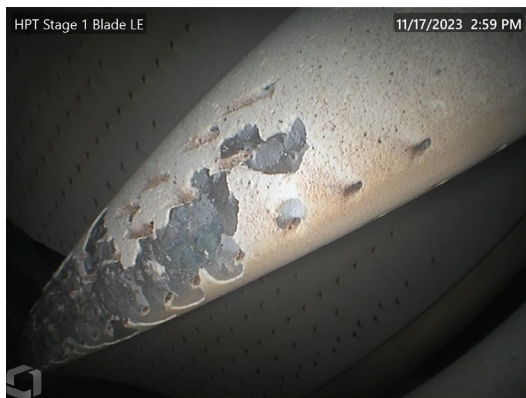
HPT_Stage_1_Blade_LE_003.JPG

Section	HPT
Stage	Stage 1 Blade
Component	LE
Defect	OXIDATION
Comments

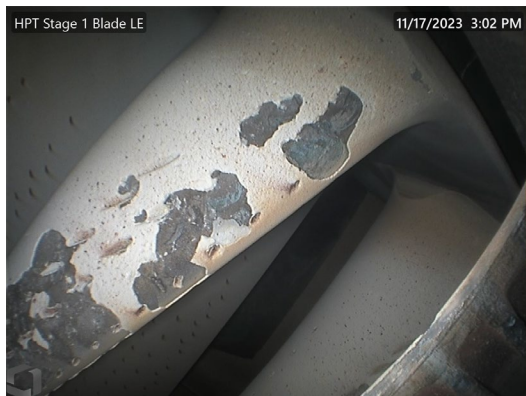
HPT_Stage_1_Blade_LE_004.JPG

Section	HPT
Stage	Stage 1 Blade
Component	LE
Defect	EROSION
Comments

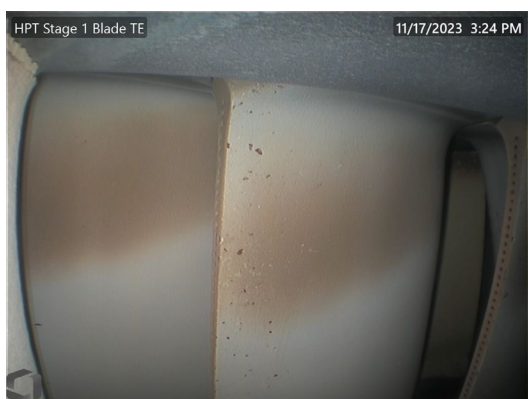
HPT_Stage_1_Blade_TE_001.JPG

Section	HPT
Stage	Stage 1 Blade
Component	TE
Defect	BURN
Comments

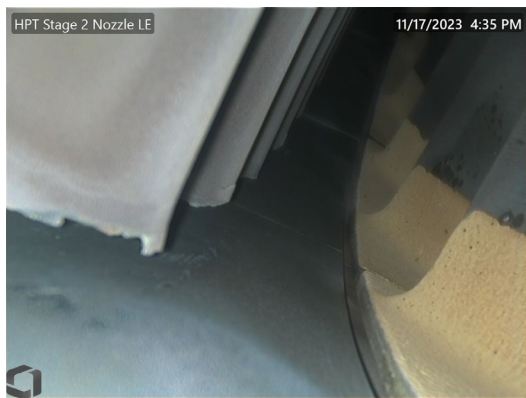
HPT_Stage_2_Nozzle_LE_002.JPG

Section	HPT
Stage	Stage 2 Blade
Component	LE
Defect	OXIDATION
Comments

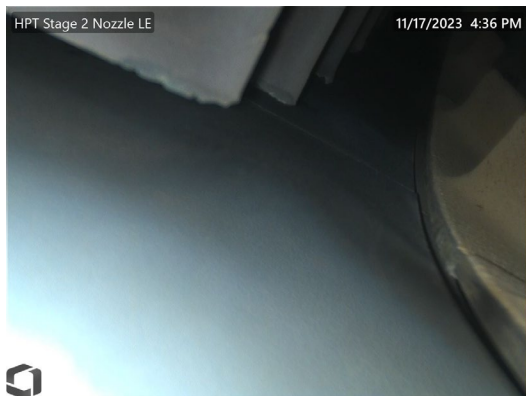
HPT_Stage_2_Nozzle_LE_003.JPG

Section	HPT
Stage	Stage 2 Blade
Component	LE
Defect	EROSION
Comments

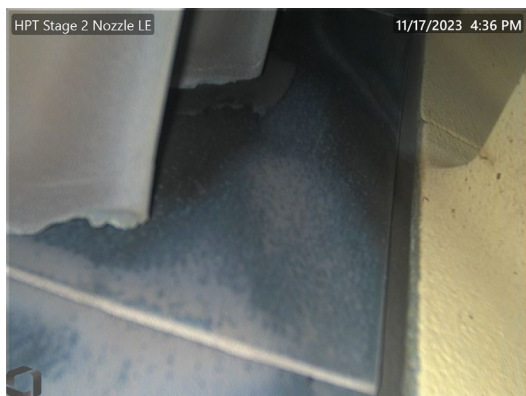
HPT_Stage_2_Nozzle_LE_004.JPG

Section	HPT
Stage	Stage 2 Blade
Component	LE
Defect	OXIDATION
Comments

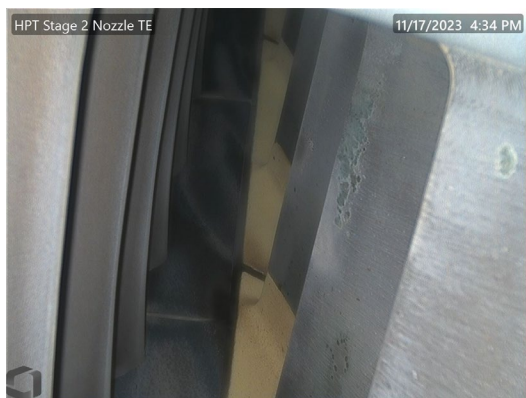
HPT_Stage_2_Nozzle_TE_001.JPG

Section	HPT
Stage	Stage 2 Nozzle
Component	TE
Defect	EROSION
Comments

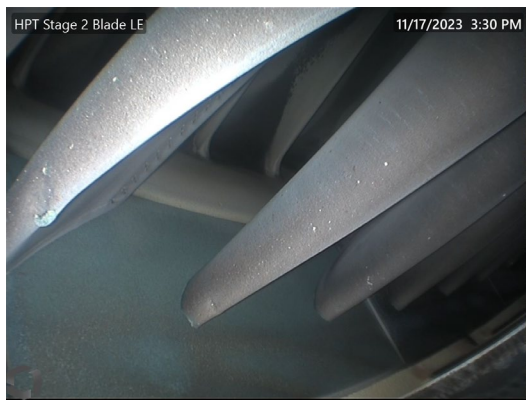
HPT_Stage_2_Blade_LE_001.JPG

Section	HPT
Stage	Stage 2 Blade
Component	LE
Defect	DENT
Comments

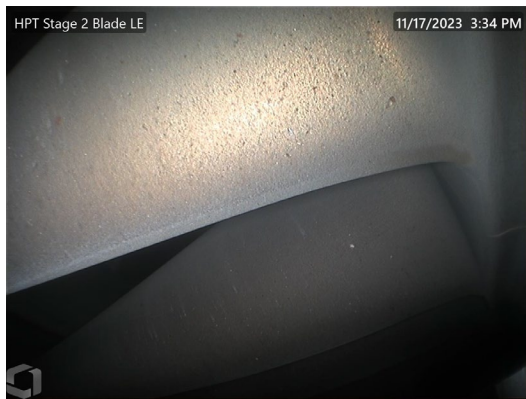
HPT_Stage_2_Blade_LE_002.JPG

Section	HPT
Stage	Stage 2 Blade
Component	LE
Defect	DENT
Comments

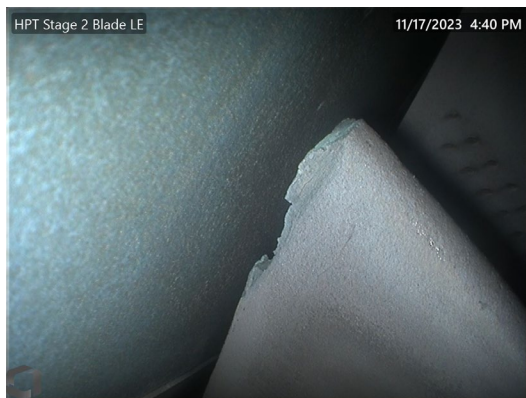
HPT_Stage_2_Blade_LE_004.JPG

Section	HPT
Stage	Stage 2 Blade
Component	LE
Defect	EROSION
Comments

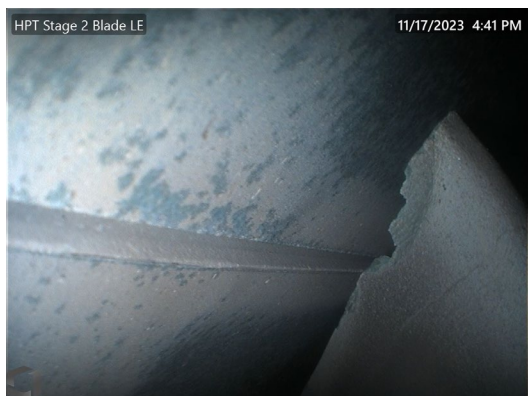
HPT_Stage_2_Blade_LE_006.JPG

Section	HPT
Stage	Stage 2 Blade
Component	LE
Length	0.256 in
Defect	OXIDATION
Comments
