LM6000 PC BORESCOPE REPORT for OMPA

Title: Borescope Inspection

ESN: 191-472 Unit # 3

Date: 10/05/2023

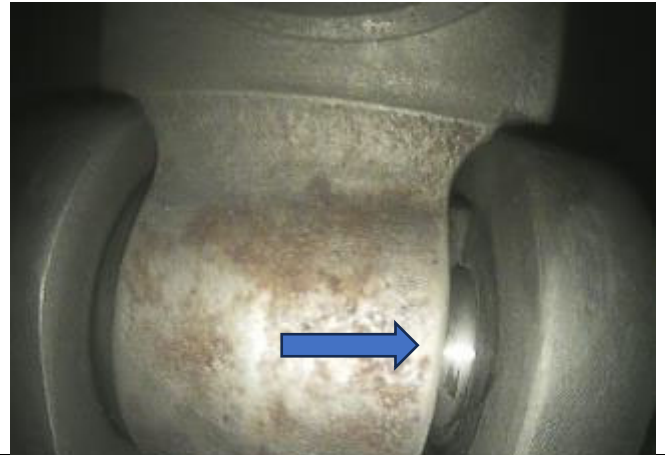
VBV Inspection / Door Hinge Bushings Broken/Missing

- Recommend water wash more frequently and add an extra rinse cycle to help with deposits.
- Recommend replacing the VBV door hinge bushings.
- PES engineering has advised the engine is released for continued operation but recommends the affected areas of the S1 Shrouds, S1 and S2 Blades be reinspected every 200 operational hours.

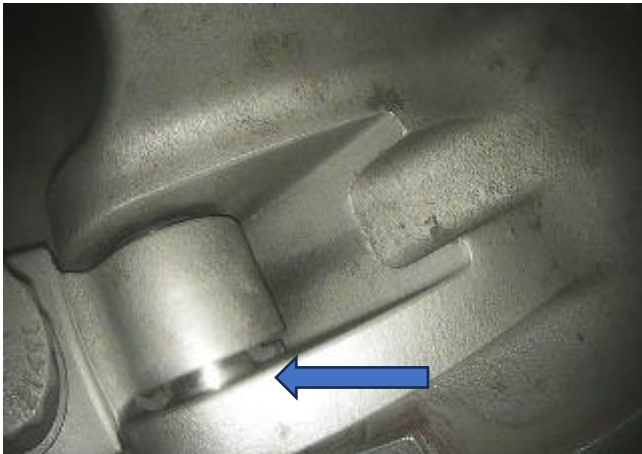
VBV Inspection / Nylon Bushings Broken/Missing

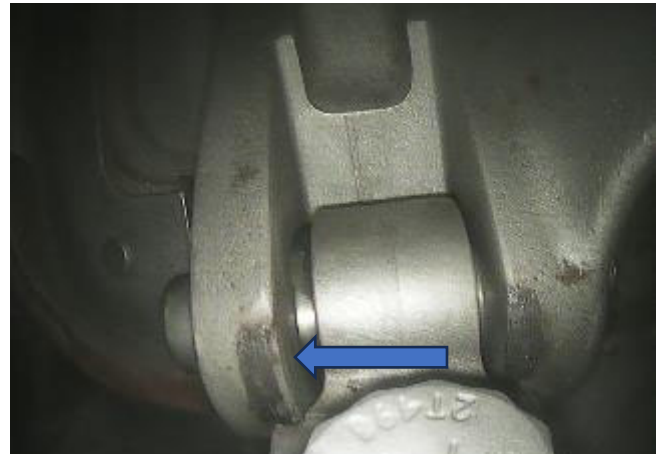
VBV Inspection / Hinge Contact Evident

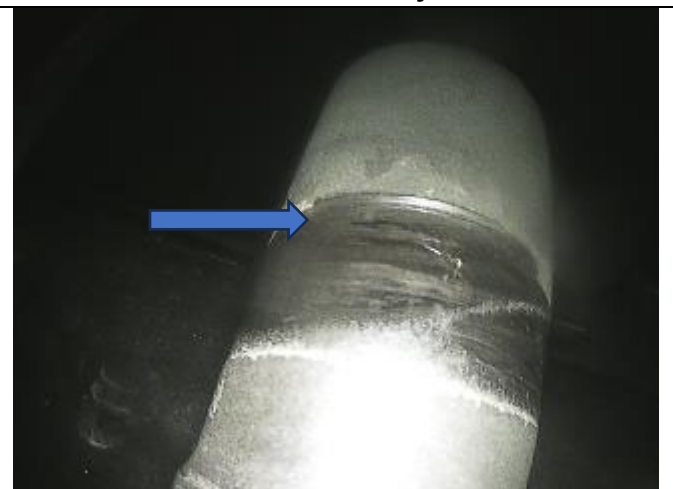
- Replaced the lower igniter with customer supplied part. The lower igniter had .012-inch wear on collar.

Igniter Lower found with wear / Replaced

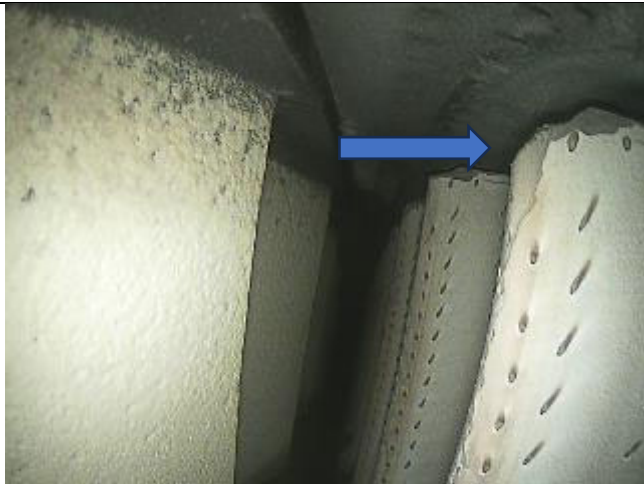
HPTN1 T/E Outer Platform. Note tip damage.

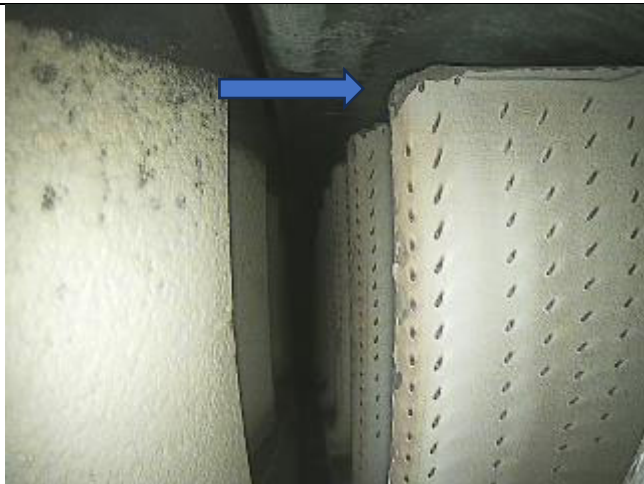
HPTR1 L/E Tip. Note Tip damage.

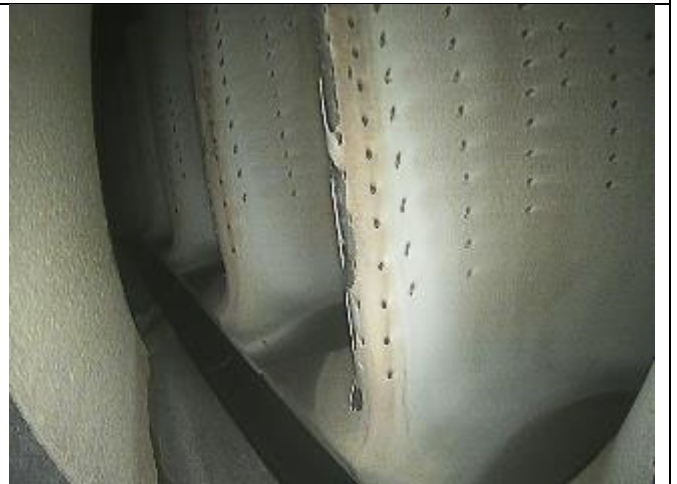
HPTR1 L/E Root. Note TBC loss.

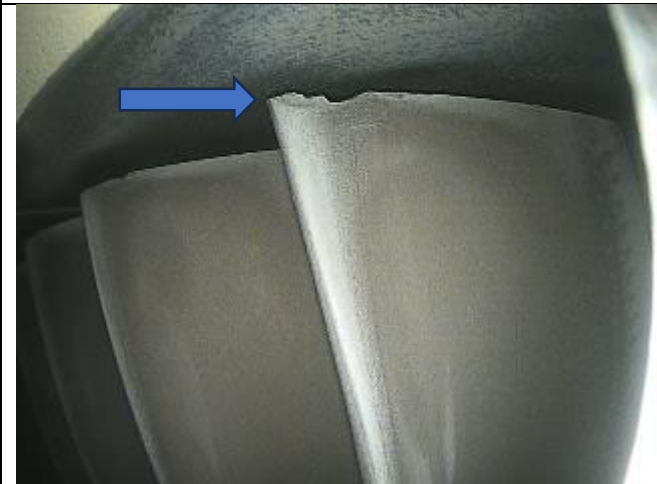
HPTR2 L/E Tip. Note tip damage.

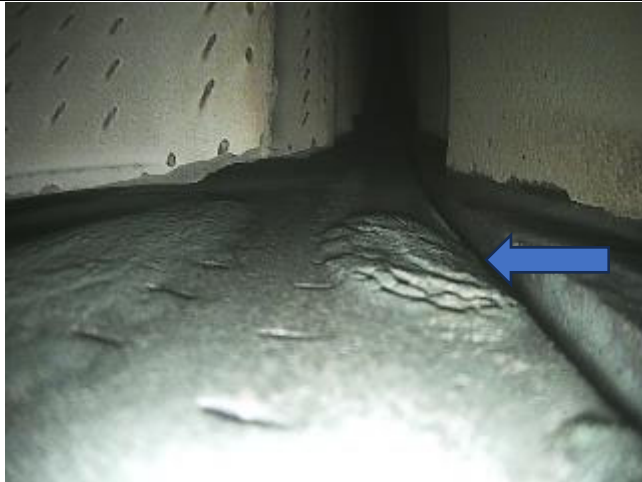
HPT Inspection Ports	S7-1,S7-2,S8-1
HPT Stage 1 Nozzles	Excessive erosion on leading edges noted. Serviceable?
HPT Stage 1 Shrouds	Stage 1 Shrouds blistering, buckling and missing material. PES Engineering to give final disposition on serviceability and repairs.
HPT Stage 1 Rotor Blades	Minor deposits and moderate TBC loss on L/E. Missing material L/E tips. PES Engineering to determine serviceability.
HPT Stage 2 Nozzles	Minor craze cracks on T/E, some TBC loss.
HPT Stage 2 Shrouds	Normal wear, Serviceable
HPT Stage 2 Rotor Blades	Serviceable? PES Engineering to determine serviceability. L/E tips missing material.
Stage 11 Check Valves	Serviceable
Borescope Plugs (S7-1,7-2)	Serviceable

HPT Stage 1 Shroud excessive blistering noted.

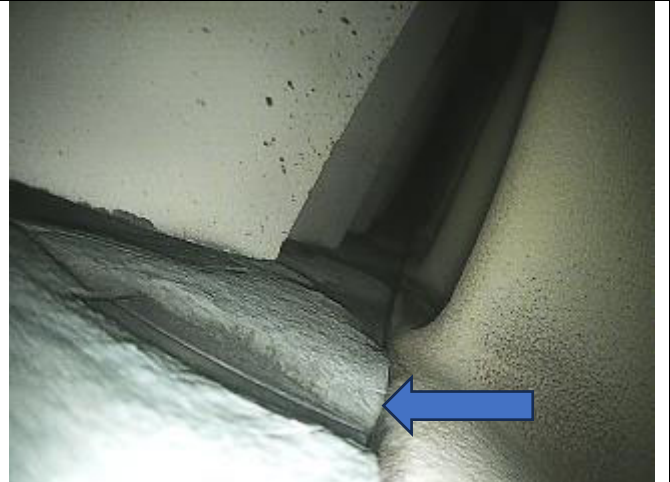
HPT stage 1 Shroud excessive material missing noted.
