LM6000 PC BORESCOPE REPORT for OMPA

Title: Borescope Inspection

ESN: 191-472 Unit # 3

Date: 10/05/2023

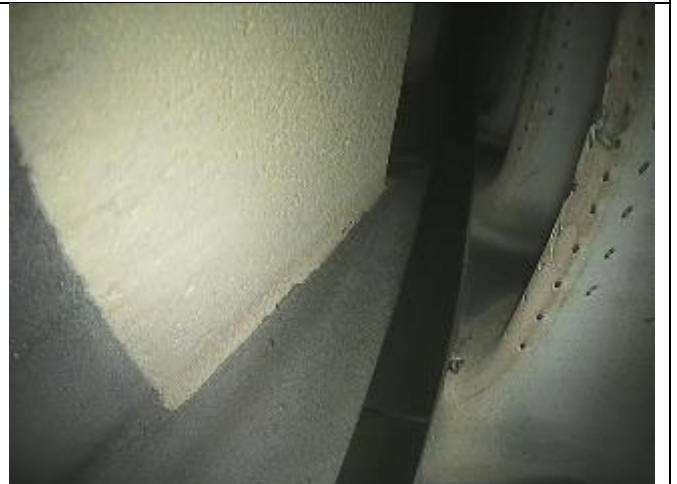
HPTN1 T/E Inner Platform.

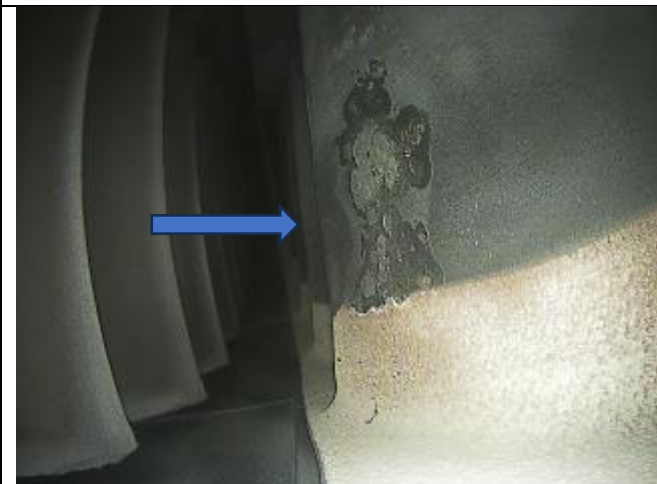
HPTN2 T/E and Outer Platform. Note erosion/deposits?

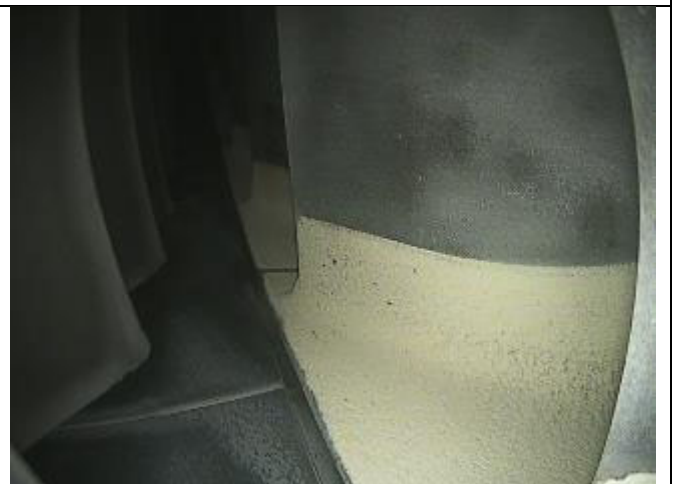
HPTN2 T/E and Outer Platform.

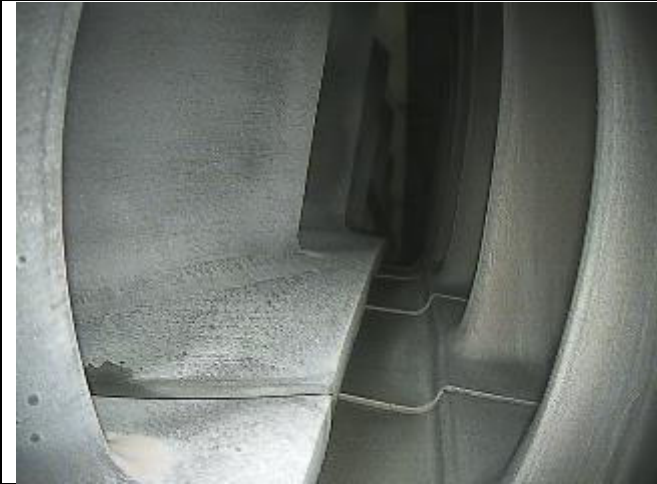
HPTN2 T/E and Inner Platform

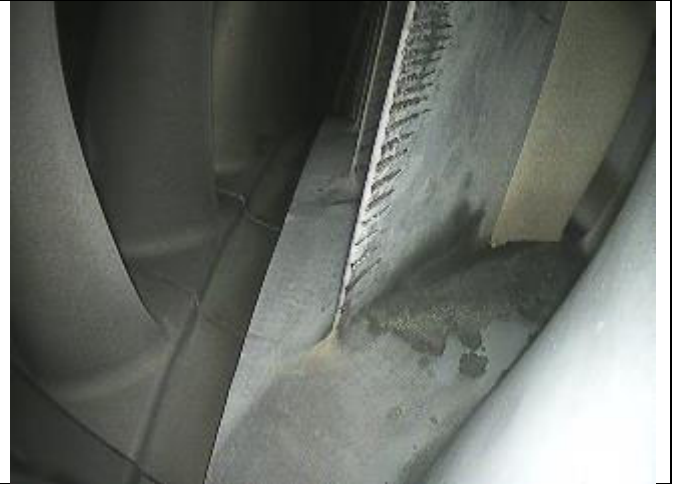
HPTN2 T/E and Inner Platform.
