LM6-208 - V.3.2

Borescope Inspection Report

Ponca City Municipal Steam Plant

Unit 3

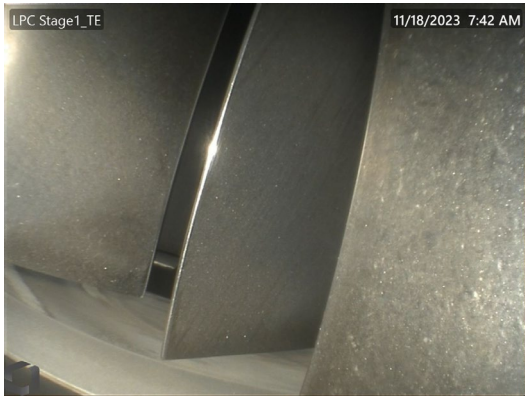
LPC_Stage1_TE_001.JPG

Section	LPC
Stage	Stage1_TE
Defect	NO DEFECTS - SERVICEABLE
Comments

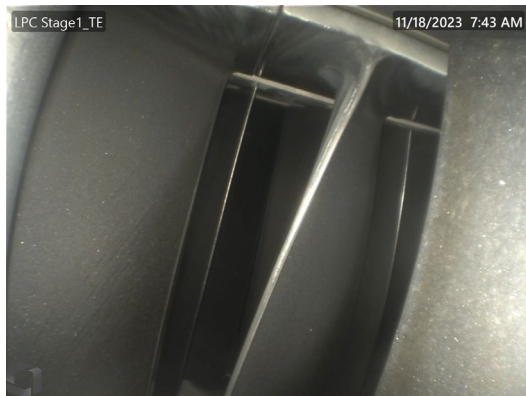
LPC_Stage1_TE_002.JPG

Section	LPC
Stage	Stage1_TE
Defect	NO DEFECTS - SERVICEABLE
Comments

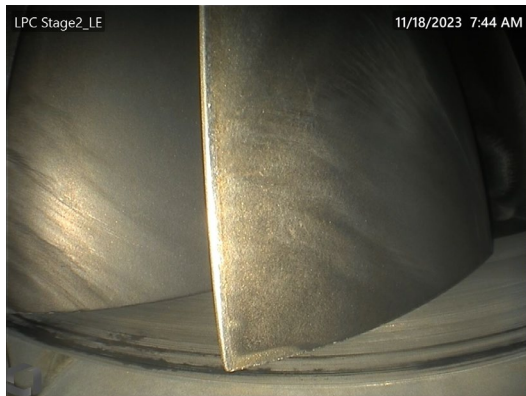
LPC_Stage2_LE_001.JPG

Section	LPC
Stage	Stage2_LE
Defect	NO DEFECTS - SERVICEABLE
Comments

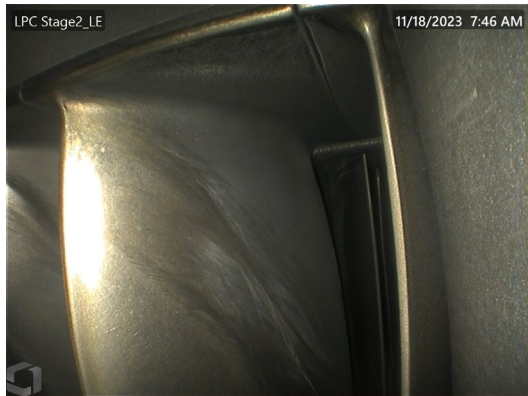
LPC_Stage2_LE_002.JPG

Section	LPC
Stage	Stage2_LE
Defect	NO DEFECTS - SERVICEABLE
Comments

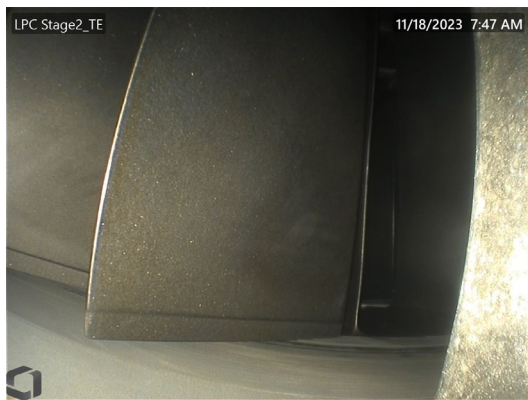
LPC_Stage2_TE_001.JPG

Section	LPC
Stage	Stage2_TE
Defect	NO DEFECTS - SERVICEABLE
Comments

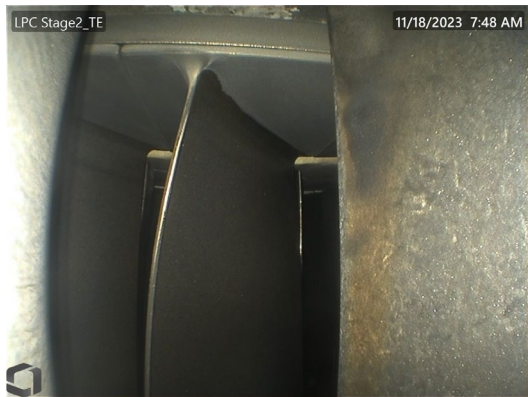
LPC_Stage2_TE_002.JPG

Section	LPC
Stage	Stage2_TE
Defect	NO DEFECTS - SERVICEABLE
Comments

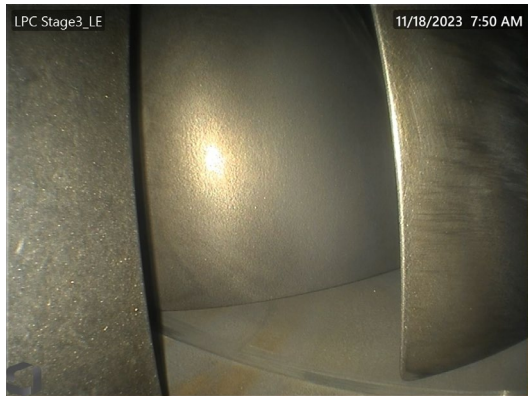
LPC_Stage3_LE_001.JPG

Section	LPC
Stage	Stage3_LE
Defect	NO DEFECTS - SERVICEABLE
Comments

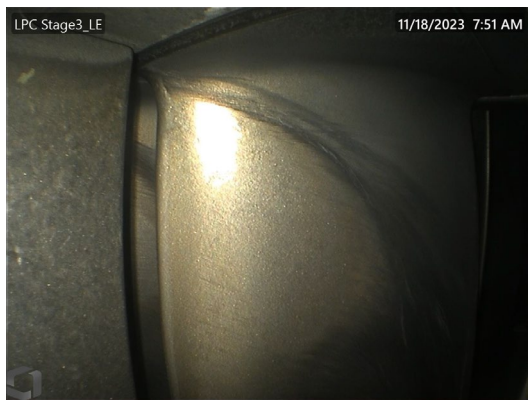
LPC_Stage3_LE_002.JPG

Section	LPC
Stage	Stage3_LE
Defect	NO DEFECTS - SERVICEABLE
Comments

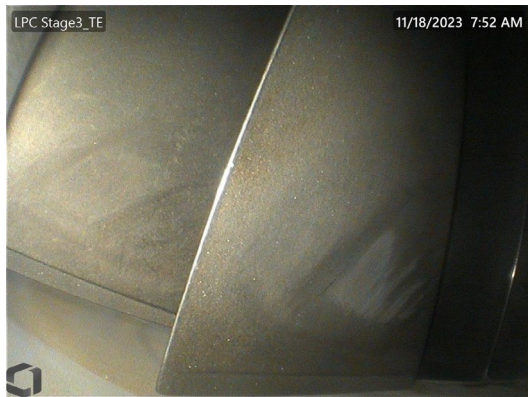
LPC_Stage3_TE_001.JPG

Section	LPC
Stage	Stage3_TE
Defect	NO DEFECTS - SERVICEABLE
Comments

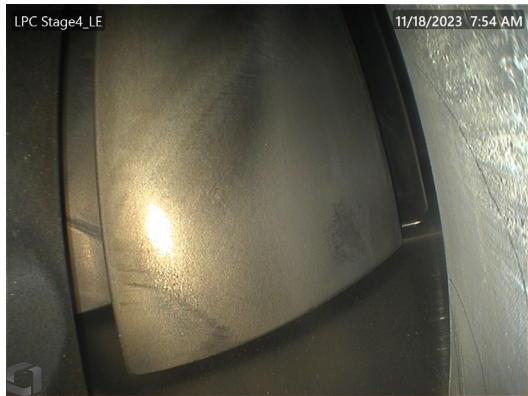
LPC_Stage4_LE_001.JPG

Section	LPC
Stage	Stage4_LE
Defect	NO DEFECTS - SERVICEABLE
Comments

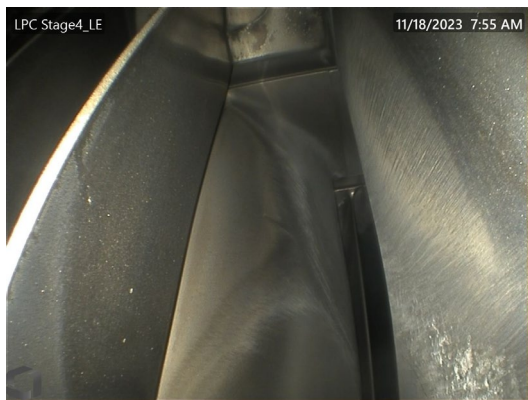
LPC_Stage4_LE_002.JPG

Section	LPC
Stage	Stage4_LE
Defect	NO DEFECTS - SERVICEABLE
Comments

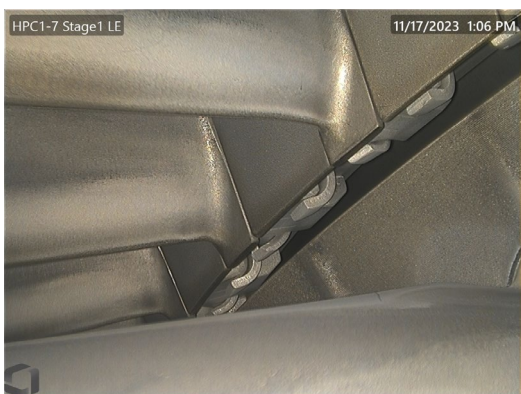
Section	HPC1-7
Stage	Stage1
Component	LE
Defect	NO DEFECTS - SERVICEABLE
Comments

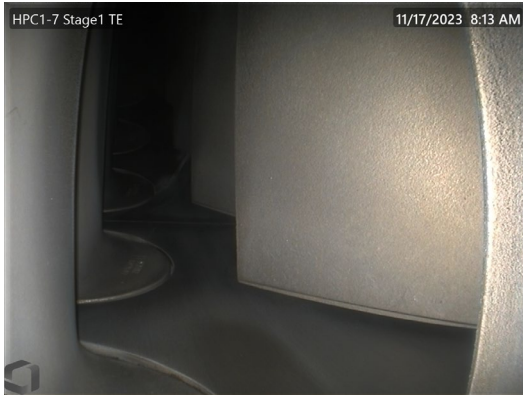
Section	HPC1-7
Stage	Stage1
Component	TE
Defect	NO DEFECTS - SERVICEABLE
Comments

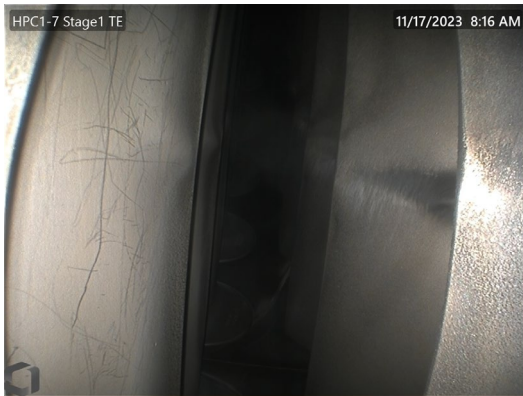
Section	HPC1-7
Stage	Stage1
Component	TE
Defect	NO DEFECTS - SERVICEABLE
Comments

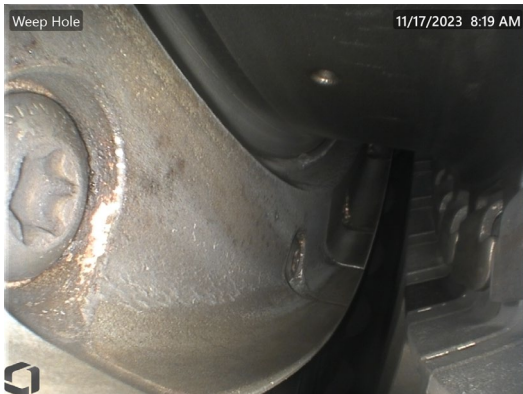
Section	HPC1-7
Stage	Stage1
Component	Weep hole
Defect	NO DEFECTS - SERVICEABLE
Comments	Dry

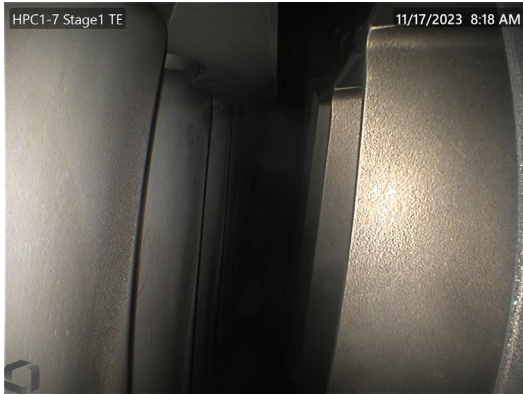
Section	HPC1-7
Stage	Stage1
Component	TE
Defect	NO DEFECTS - SERVICEABLE
Comments

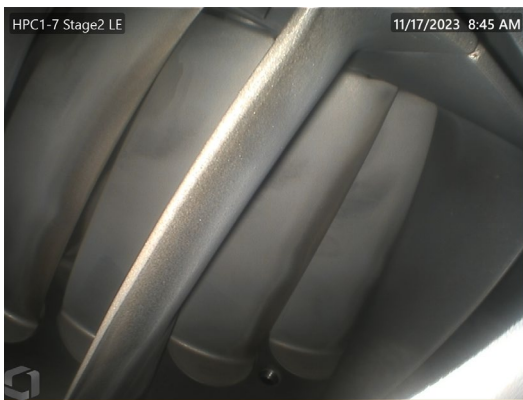
Section	HPC1-7
Stage	Stage2
Component	LE
Defect	NO DEFECTS - SERVICEABLE
Comments

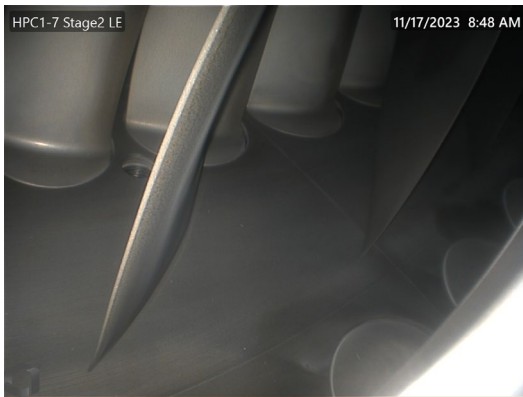
Section	HPC1-7
Stage	Stage2
Component	LE
Defect	NO DEFECTS - SERVICEABLE
Comments

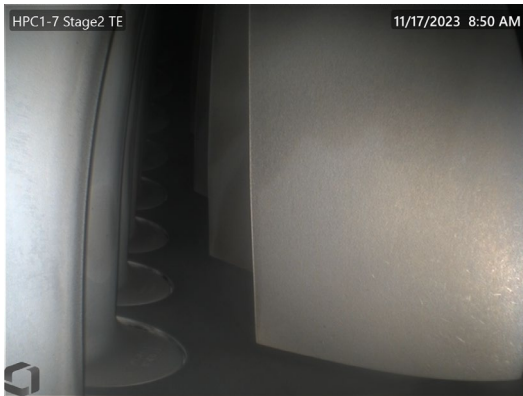
Section	HPC1-7
Stage	Stage2
Component	TE
Defect	NO DEFECTS - SERVICEABLE
Comments

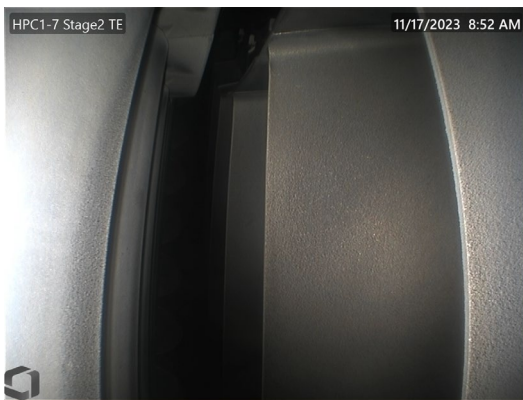
Section	HPC1-7
Stage	Stage2
Component	TE
Defect	NO DEFECTS - SERVICEABLE
Comments

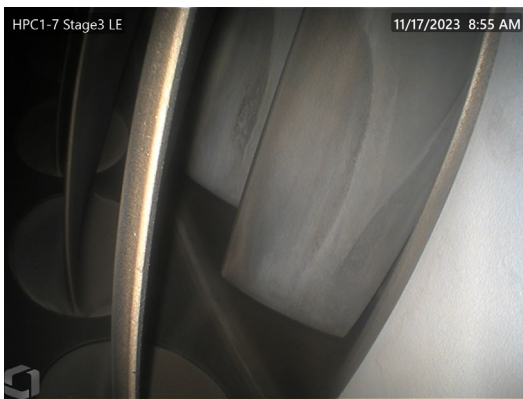
Section	HPC1-7
Stage	Stage3
Component	LE
Defect	NO DEFECTS - SERVICEABLE
Comments

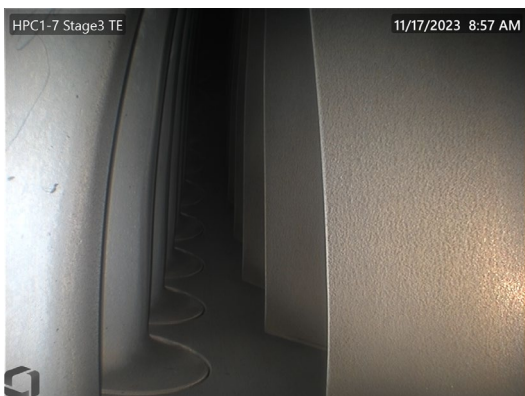
Section	HPC1-7
Stage	Stage3
Component	TE
Defect	NO DEFECTS - SERVICEABLE
Comments

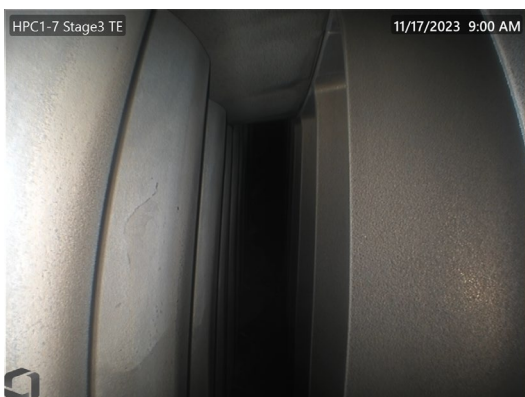
Section	HPC1-7
Stage	Stage3
Component	TE
Defect	NO DEFECTS - SERVICEABLE
Comments

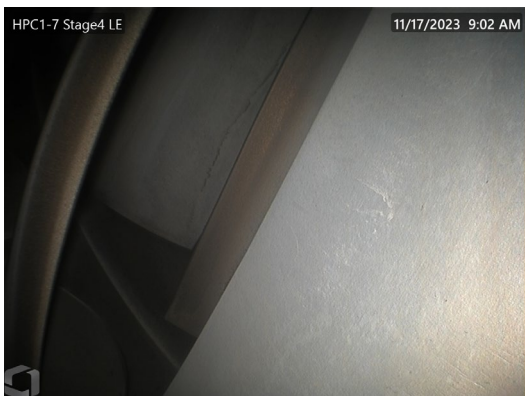
Section	HPC1-7
Stage	Stage4
Component	LE
Defect	NO DEFECTS - SERVICEABLE
Comments

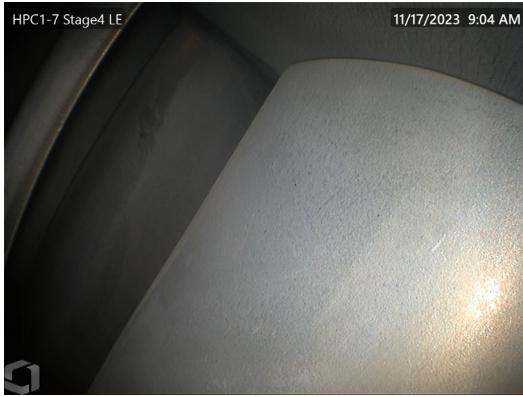
Section	HPC1-7
Stage	Stage4
Component	LE
Defect	NO DEFECTS - SERVICEABLE
Comments

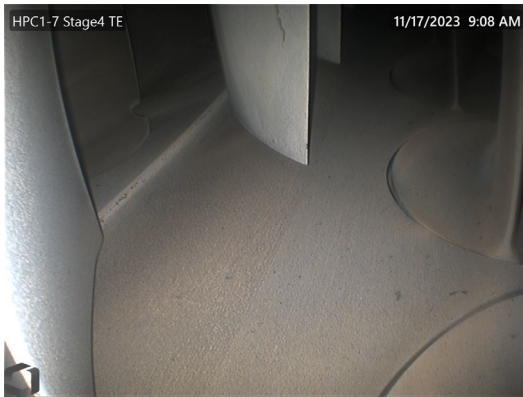
Section	HPC1-7
Stage	Stage4
Component	TE
Defect	NO DEFECTS - SERVICEABLE
Comments

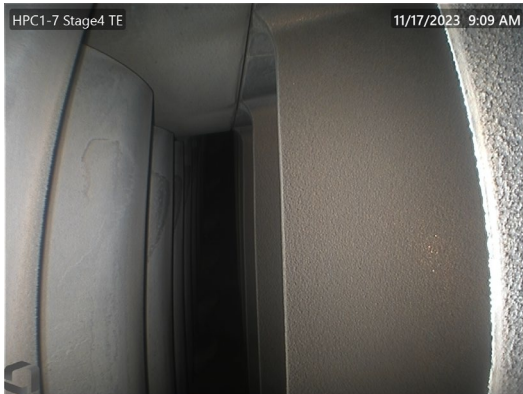
Section	HPC1-7
Stage	Stage4
Component	TE
Defect	NO DEFECTS - SERVICEABLE
Comments

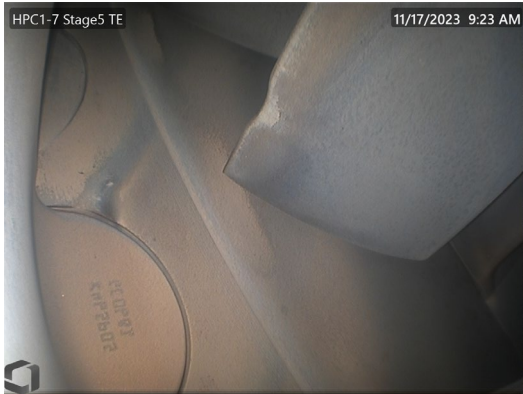
Detail Findings:	<ul style="list-style-type: none"> HPC Stg 6 leading edge has one dented blade. HPC Stg 7 leading edge has one dented blade. HPC Stg 8 trialing edge has one dented blade and another one with minor dent. HPC stg 8 trialing edge has one blade missing material from the tip. HPC Stg 10 Trialing edge has one blade missing material. HPC Stg 11 leading edge Has three blades with minor nick. HPC Stg 11 leading edge has three dented blades. HPC Stg 13 leading edge has one Dented blade. HPC Stg 14 leading edge has one dented blade.
PAC Number (if available):	AERO-20231118-0243
Notifications (SM/CPM/PM/ENGR/SL or FSRM):	Eric Bergeron

Section	HPC1-7
Stage	Stage6
Component	LE
Defect	Dent
Comments

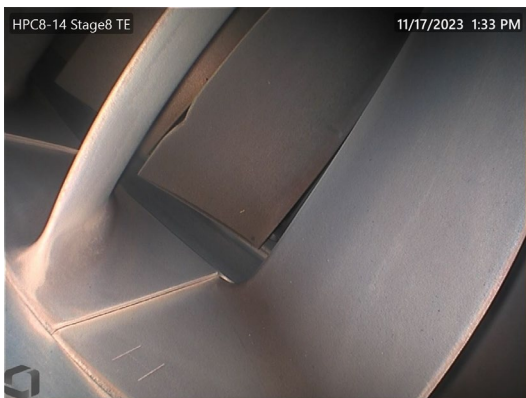
HPC8-14_Stage8_TE_001.JPG

Section	HPC8-14
Stage	Stage8
Component	TE
Defect	DENT
Comments

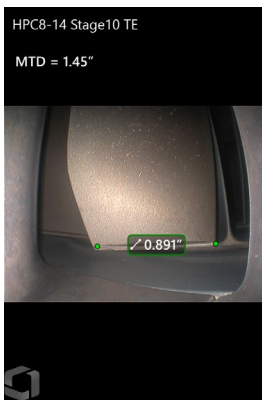
Section	HPC8-14
Stage	Stage10
Component	TE
Defect	Missing material measurement for comparison
Comments

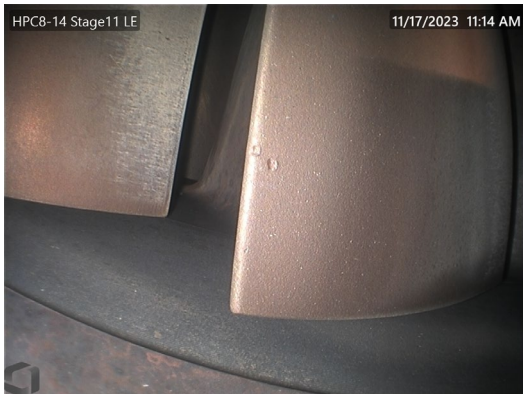
Section	HPC8-14
Stage	Stage11
Component	LE
Defect	Minor nick
Comments

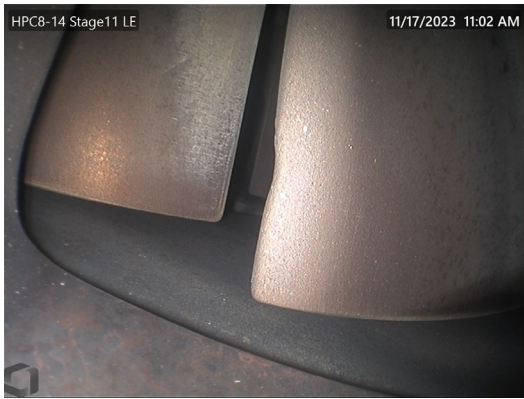
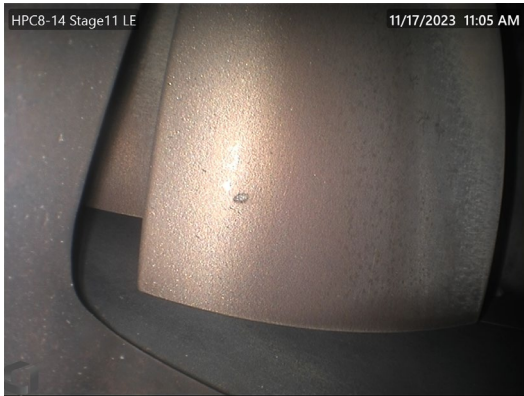
Section	HPC8-14
Stage	Stage11
Component	LE
Defect	
Comments

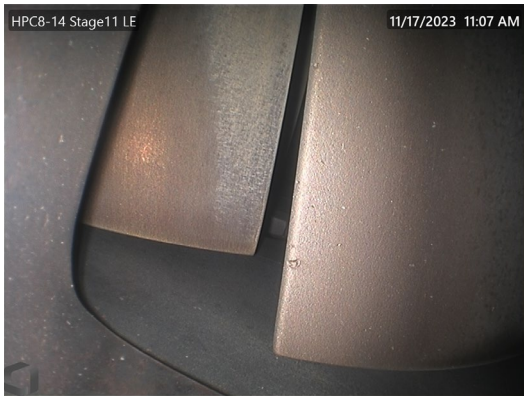
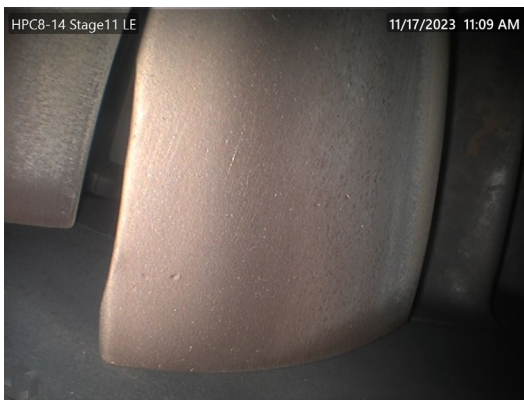
Section	HPC8-14
Stage	Stage11
Component	LE
Defect	
Comments

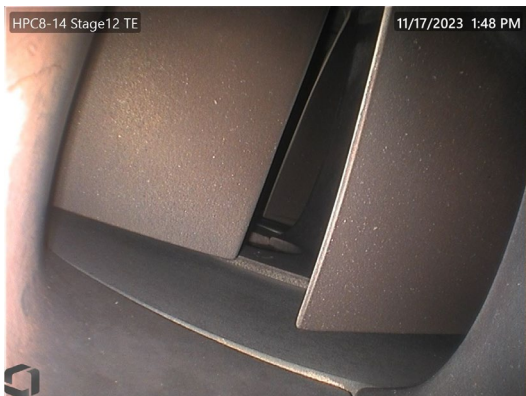
HPC8-14_Stage12_TE_001.JPG

Section	HPC8-14
Stage	Stage12
Component	TE
Defect	NO DEFECTS - SERVICEABLE
Comments

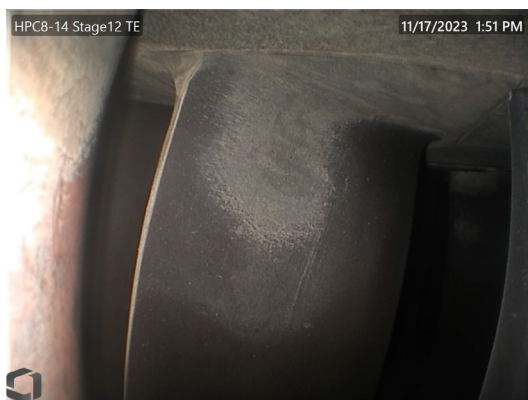
HPC8-14_Stage12_TE_002.JPG

Section	HPC8-14
Stage	Stage12
Component	TE
Defect	DEPOSIT
Comments

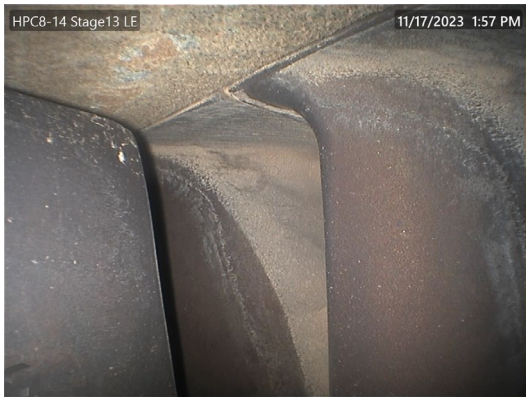
HPC8-14_Stage13_LE_003.JPG

Section	HPC8-14
Stage	Stage13
Component	LE
Defect	NO DEFECTS - SERVICEABLE
Comments

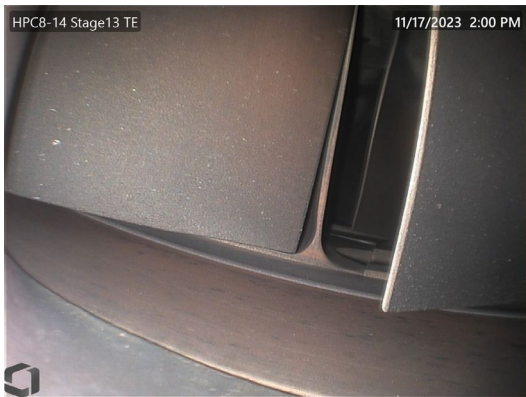
HPC8-14_Stage13_TE_001.JPG

Section	HPC8-14
Stage	Stage13
Component	TE
Defect	NO DEFECTS - SERVICEABLE
Comments

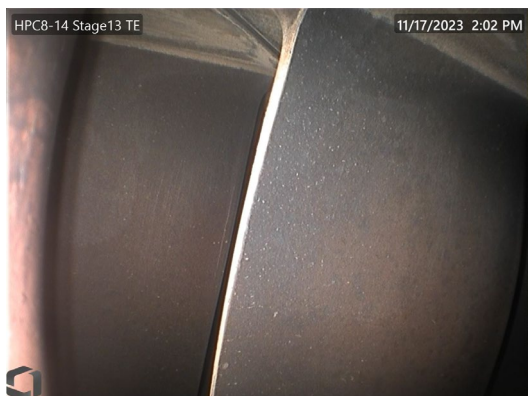
HPC8-14_Stage13_TE_002.JPG

Section	HPC8-14
Stage	Stage13
Component	TE
Defect	NO DEFECTS - SERVICEABLE
Comments

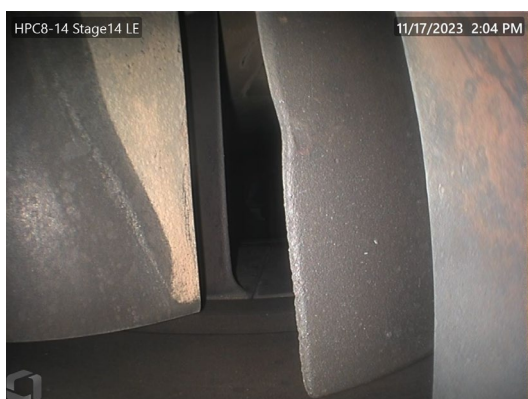
HPC8-14_Stage14_LE_001.JPG

Section	HPC8-14
Stage	Stage14
Component	LE
Defect	DENT
Comments

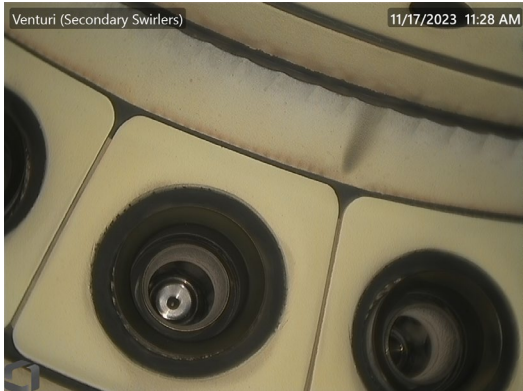
Section	Combustor
Defect	Secondary swirler
Comments	Serviceable

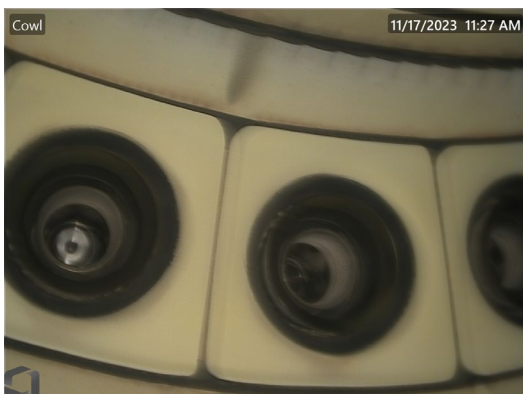
Section	Cowl
Defect	Secondary swirler
Comments	Serviceable

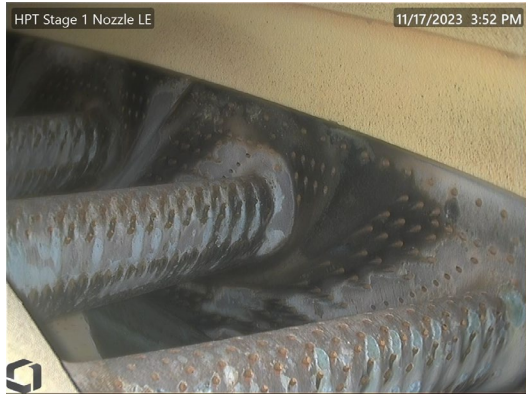
HPT_Stage_1_Nozzle_LE_001.JPG

High Pressure Turbine	
Inspection Area	Comment
<input type="checkbox"/> Inspect stage 1 and 2 shrouds for cracks, missing material, wear and erosion.	Excessive Oxidation and erosion
<input type="checkbox"/> Stage 1 HPT Shrouds, BSI port S7-2	Excessive Oxidation and erosion
<input type="checkbox"/> Stage 2 HPT Shrouds, BSI port P48 & T48 probe	Excessive Oxidation and erosion
<input type="checkbox"/> Inspect stage 1 and 2 blades for missing TBC coating, oxidation parent material, plugged cooling holes.	Excessive Oxidation and erosion
<input type="checkbox"/> Stage 1 HPT (Qty 80) Leading Edge, BSI port S7-1 and Trailing Edge, S7-2	Excessive Oxidation and erosion
<input type="checkbox"/> Stage 2 HPT (Qty 74) Leading Edge, BSI port S7-2 and Trailing Edge, P48 or T48 probe	Excessive Oxidation and erosion
<input type="checkbox"/> Inspect stage 1 and 2 blade airfoils for cracks, nicks, tears, burrs, dents and missing material,	Excessive Oxidation and erosion

Section	HPT
Stage	Stage 1 Nozzle
Component	LE
Defect	EROSION
Comments

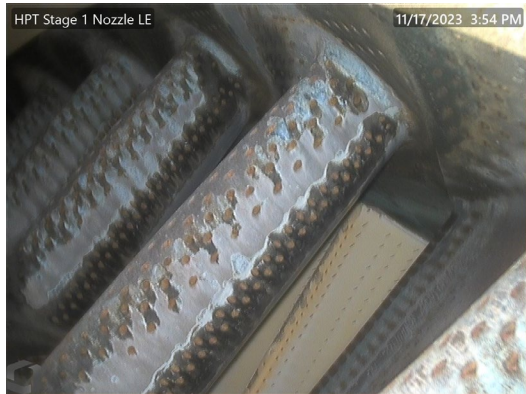
HPT_Stage_1_Nozzle_LE_002.JPG

Section	HPT
Stage	Stage 1 Nozzle
Component	LE
Defect	EROSION
Comments

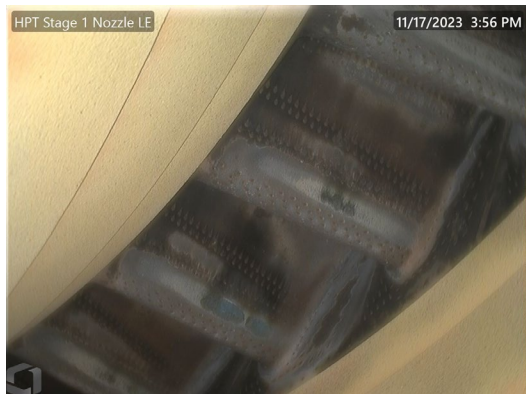
HPT_Stage_1_Nozzle_LE_003.JPG

Section	HPT
Stage	Stage 1 Nozzle
Component	LE
Defect	EROSION
Comments

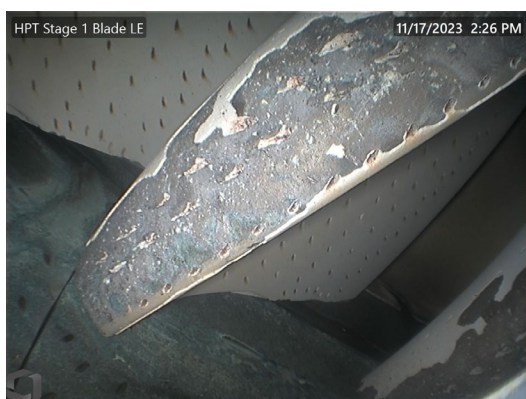
HPT_Stage_1_Blade_LE_001.JPG

Section	HPT
Stage	Stage 1 Blade
Component	LE
Defect	EROSION
Comments

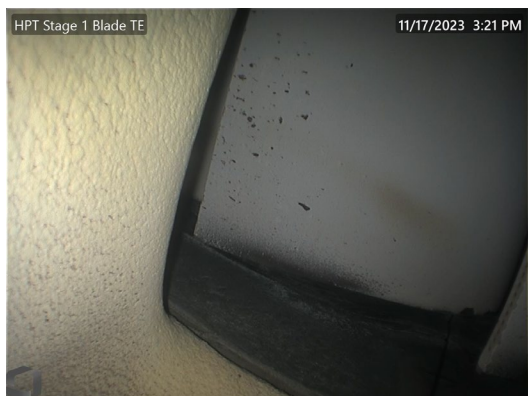
HPT_Stage_1_Blade_TE_001.JPG

Section	HPT
Stage	Stage 1 Blade
Component	TE
Defect	BURN
Comments

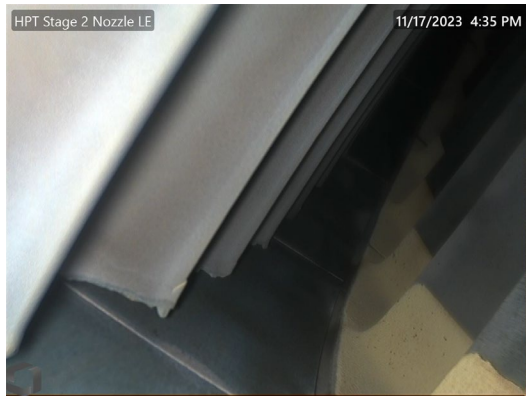
HPT_Stage_2_Nozzle_LE_002.JPG

Section	HPT
Stage	Stage 2 Blade
Component	LE
Defect	OXIDATION
Comments

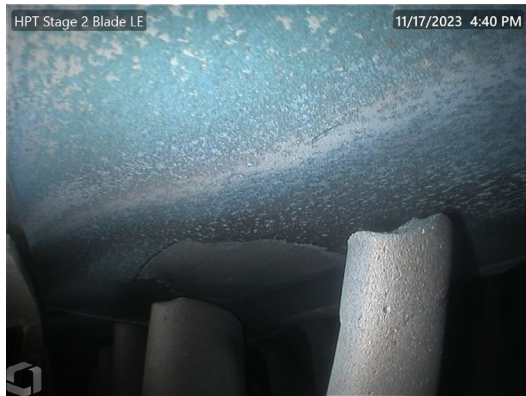
HPT_Stage_2_Blade_LE_004.JPG

Section	HPT
Stage	Stage 2 Blade
Component	LE
Defect	EROSION
Comments

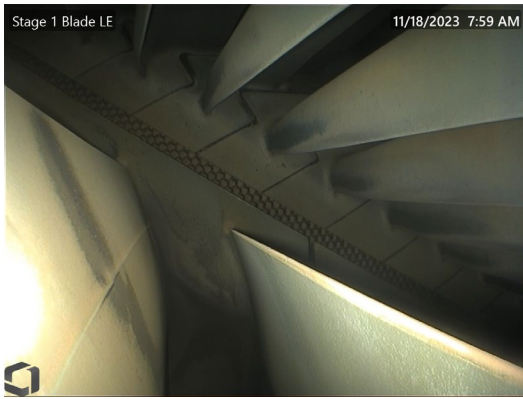
Stage_1_Blade_LE_001.JPG

Section	LPT
Stage	Stage 1 Blade
Component	LE
Defect	NO DEFECTS - SERVICEABLE
Comments

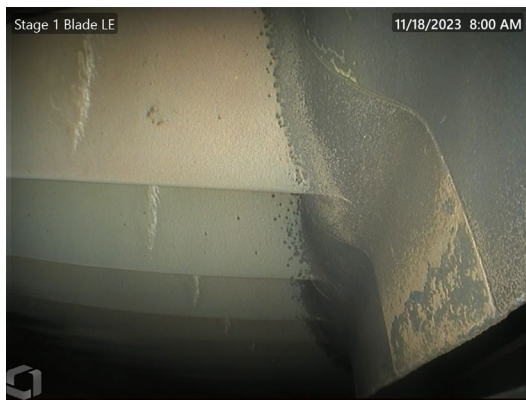
Stage_1_Blade_LE_002.JPG

Section	LPT
Stage	Stage 1 Blade
Component	LE
Defect	NO DEFECTS - SERVICEABLE
Comments

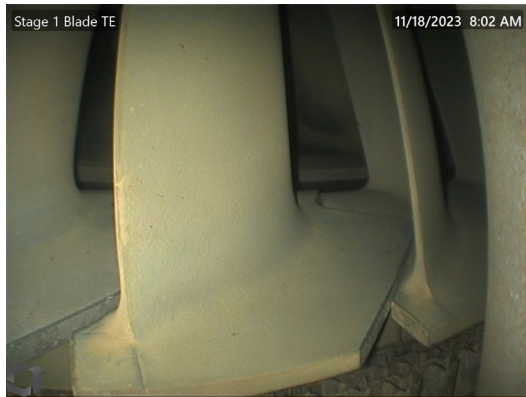
Stage_1_Blade_TE_001.JPG

Section	LPT
Stage	Stage 1 Blade
Component	TE
Defect	NO DEFECTS - SERVICEABLE
Comments

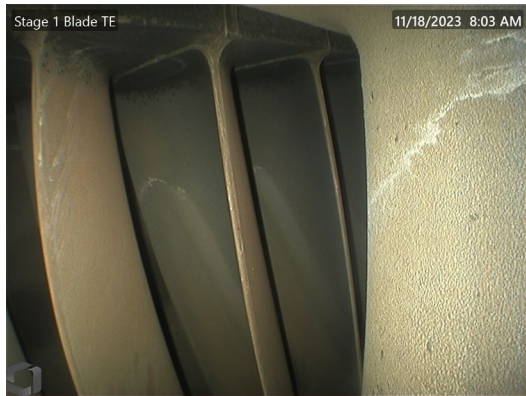
Stage_1_Blade_TE_002.JPG

Section	LPT
Stage	Stage 1 Blade
Component	TE
Defect	NO DEFECTS - SERVICEABLE
Comments

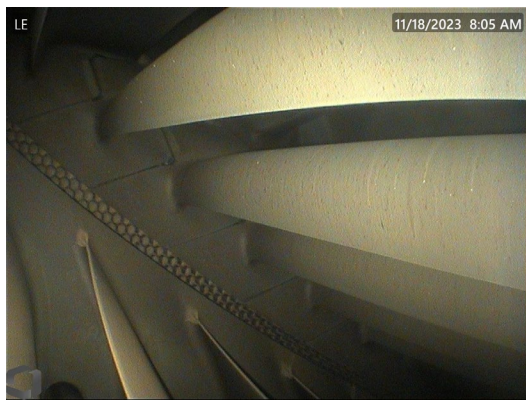
LE_001.JPG

Section	LPT
Stage	Stage 2 Blade
Component	LE
Defect	NO DEFECTS - SERVICEABLE
Comments

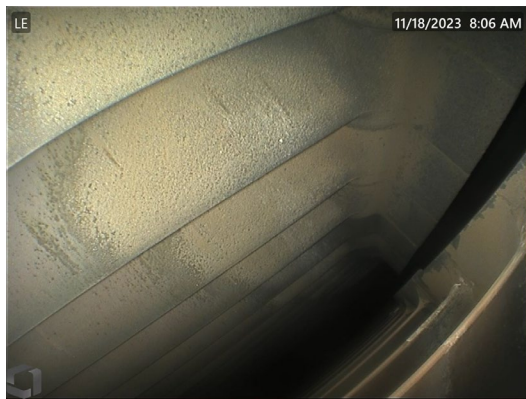
LE_002.JPG

Section	LPT
Stage	Stage 2 Blade
Component	LE
Defect	NO DEFECTS - SERVICEABLE
Comments

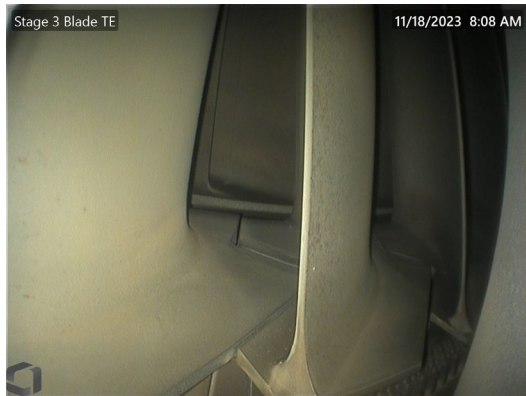
Stage_3_Blade_TE_001.JPG

Section	LPT
Stage	Stage 3 Blade
Component	TE
Defect	NO DEFECTS - SERVICEABLE
Comments

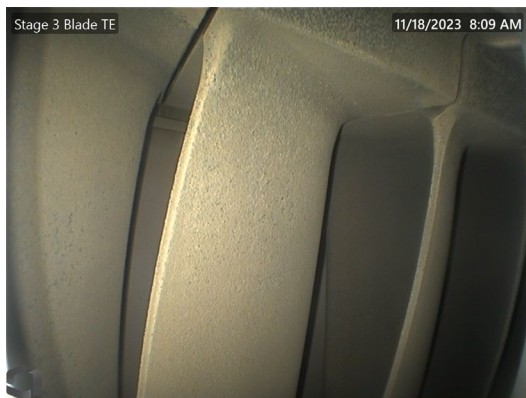
Stage_3_Blade_TE_002.JPG

Section	LPT
Stage	Stage 3 Blade
Component	TE
Defect	NO DEFECTS - SERVICEABLE
Comments

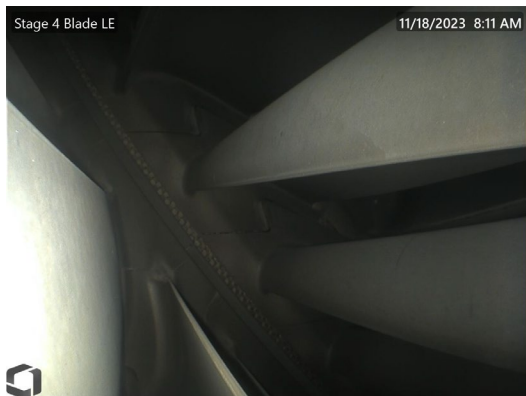
Stage_4_Blade_LE_001.JPG

Section	LPT
Stage	Stage 4 Blade
Component	LE
Defect	NO DEFECTS - SERVICEABLE
Comments

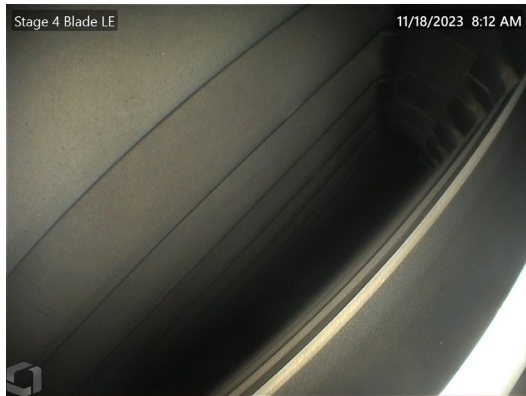
Stage_4_Blade_LE_002.JPG

Section	LPT
Stage	Stage 4 Blade
Component	LE
Defect	NO DEFECTS - SERVICEABLE
Comments

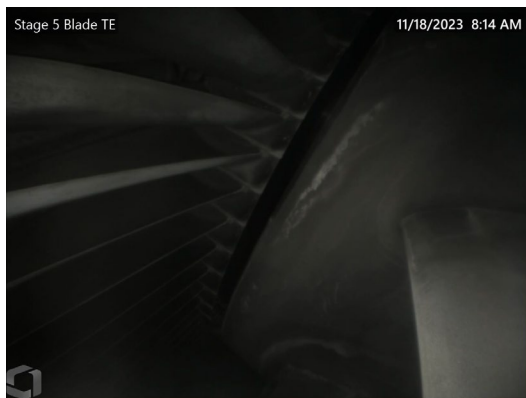
Stage_5_Blade_TE_001.JPG

Section	LPT
Stage	Stage 5 Blade
Component	TE
Defect	NO DEFECTS - SERVICEABLE
Comments

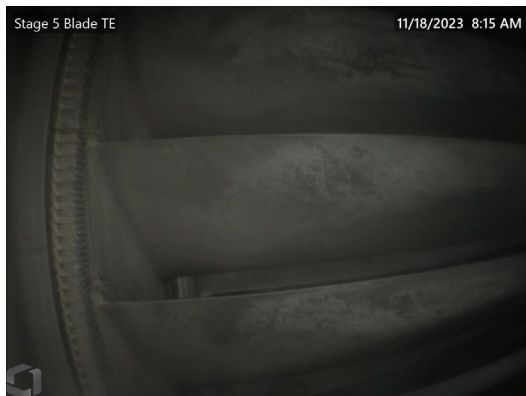
Stage_5_Blade_TE_002.JPG

Section	LPT
Stage	Stage 5 Blade
Component	TE
Defect	NO DEFECTS - SERVICEABLE
Comments
