LM6000 PC BORESCOPE REPORT for OMPA

Title: Borescope Inspection

ESN: 191-472 Unit # 3

Date: 10/05/2023

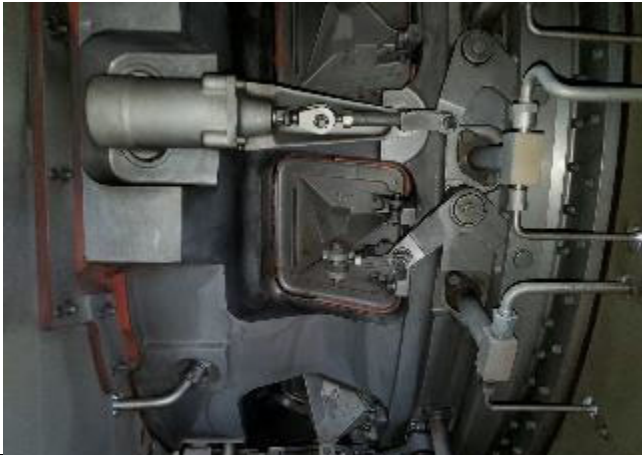
LPC Inspection Ports:	S4-2 to S4-5
LPC (Rotor Blades – Stages 0-4)	Minor deposits, Serviceable
LPC (Vaness – Stages 0-4)	Minor deposits, Serviceable
LPC Inner Shrouds & Bushings	Serviceable, no bushing protrusion noted.
Additional Comments	VBV system inspection performed. Door hinge nylon bushings missing and broken.

VBV Inspection

- Recommend water wash more frequently and add an extra rinse cycle to help with deposits.
- Recommend replacing the VBV door hinge bushings.
- PES engineering has advised the engine is released for continued operation but recommends the affected areas of the S1 Shrouds, S1 and S2 Blades be reinspected every 200 operational hours.

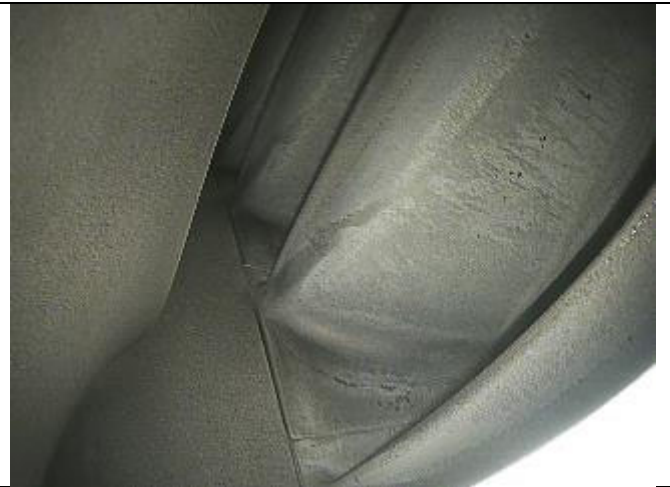
HPC Stage 5 L/E Root

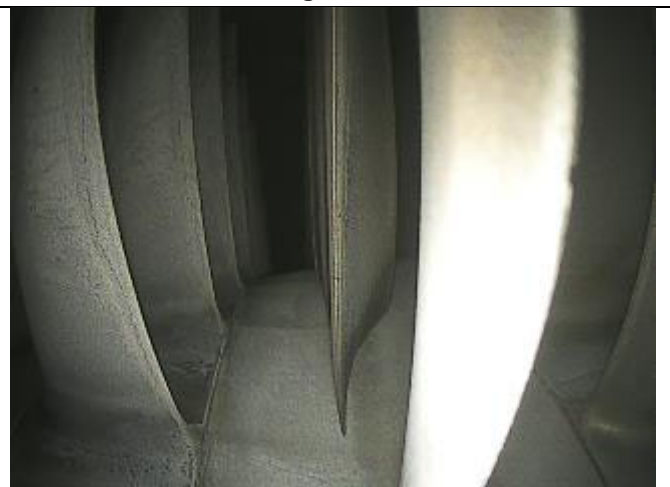
HPC Stage 5 T/E Root

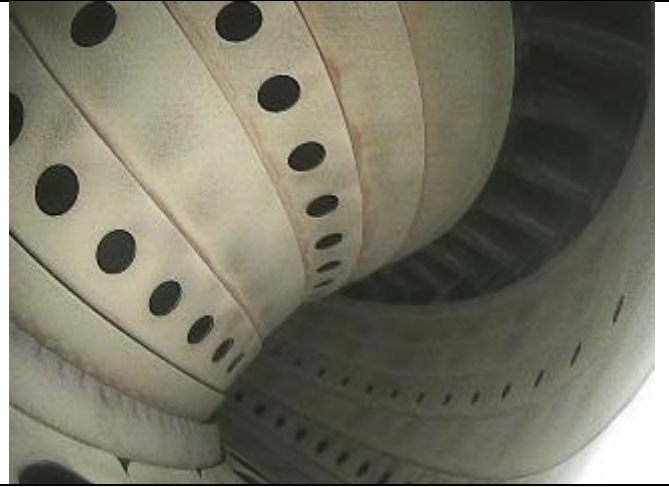
Combustor Overview

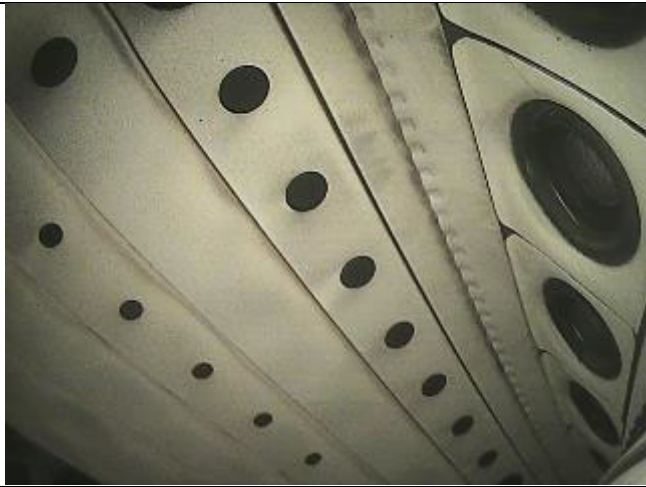
Combustor Splash Plates and outer liner

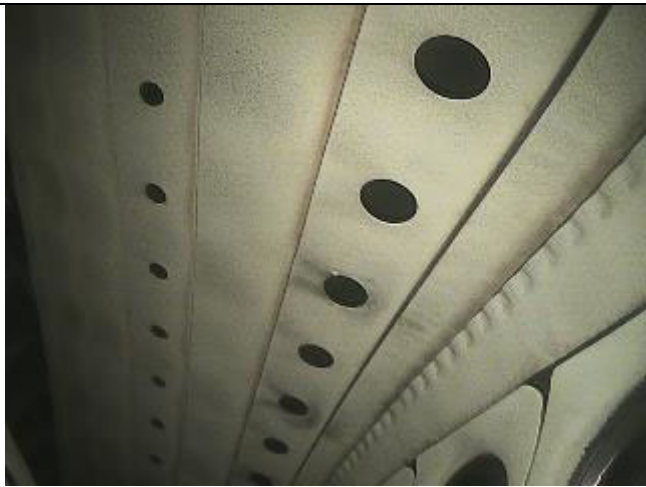
Combustor Outer Liner

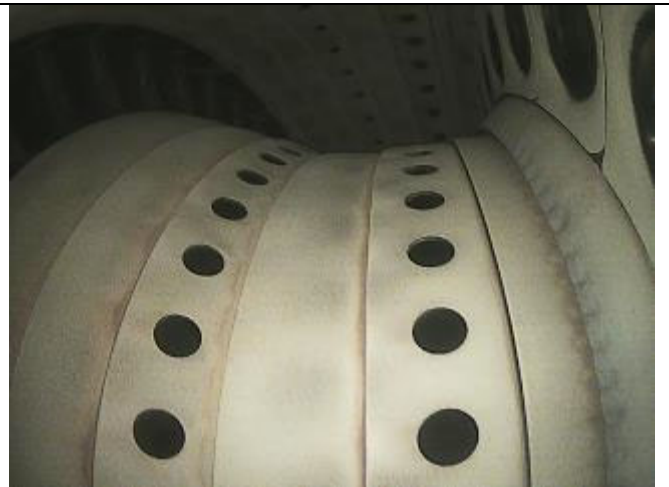
Combustor Inner Liner

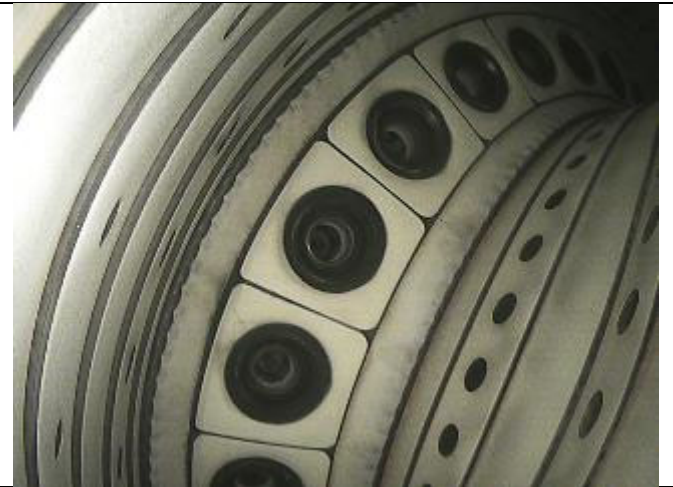
Combustor Splash Plates

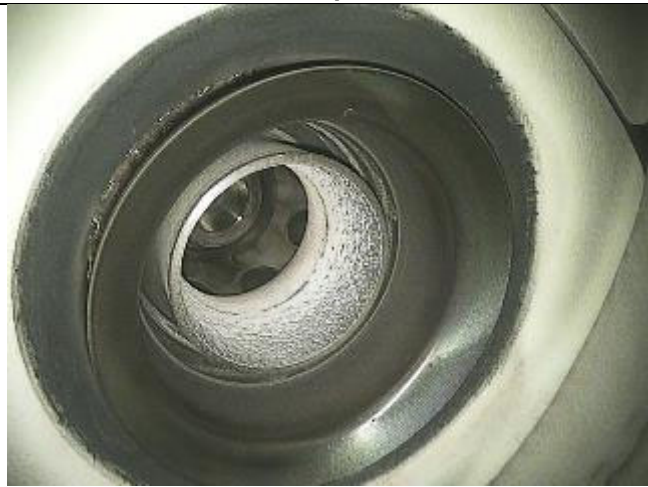
Combustor Secondary Swirler

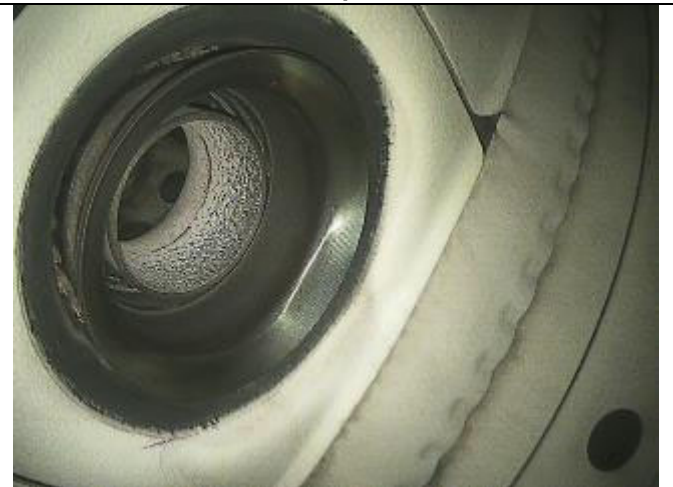
Combustor Secondary Swirler

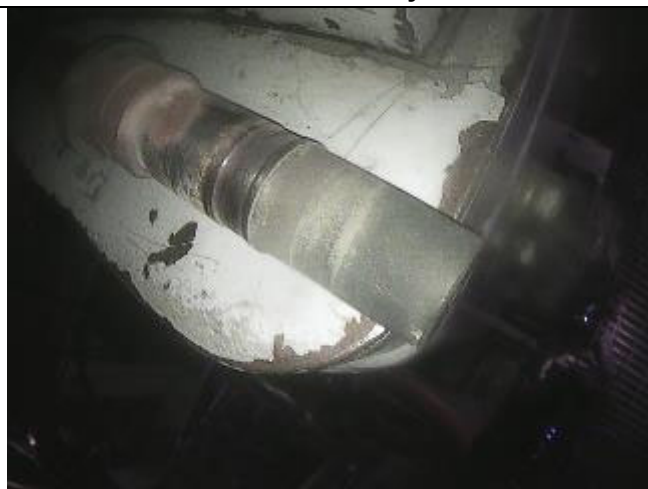
Igniter Upper

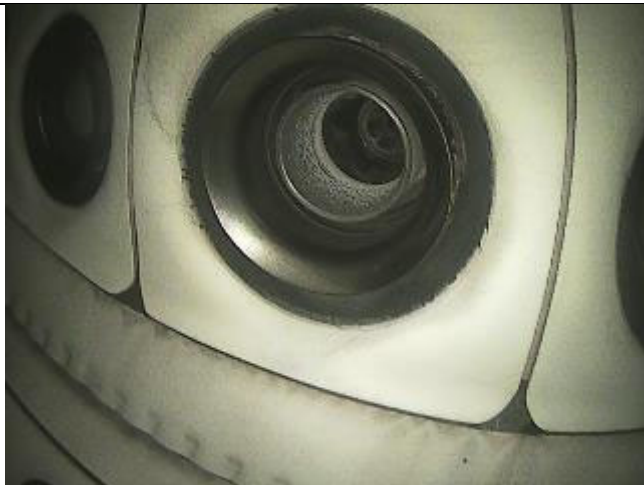
Combustor Secondary Swirler and splash plates

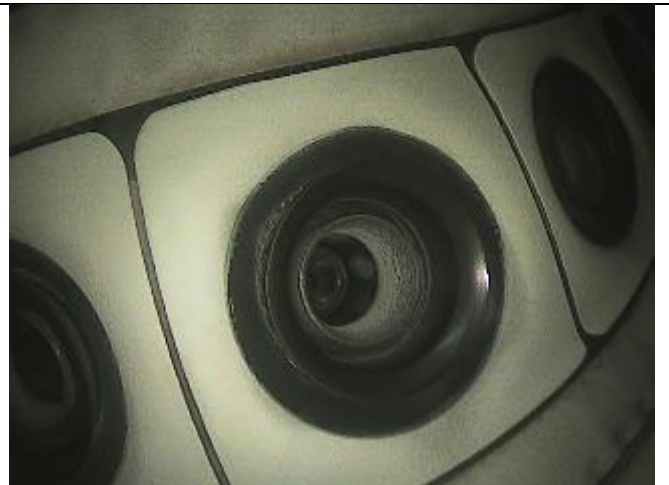
Combustor Secondary Swirler and splash plates

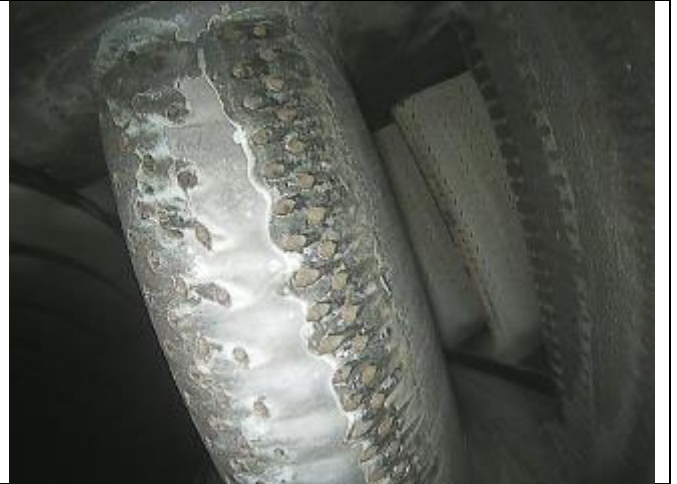
HPT Inspection Ports	S7-1,S7-2,S8-1
HPT Stage 1 Nozzles	Excessive erosion on leading edges noted. Serviceable?
HPT Stage 1 Shrouds	Stage 1 Shrouds blistering, buckling and missing material. PES Engineering to give final disposition on serviceability and repairs.
HPT Stage 1 Rotor Blades	Minor deposits and moderate TBC loss on L/E. Missing material L/E tips. PES Engineering to determine serviceability.
HPT Stage 2 Nozzles	Minor craze cracks on T/E, some TBC loss.
HPT Stage 2 Shrouds	Normal wear, Serviceable
HPT Stage 2 Rotor Blades	Serviceable? PES Engineering to determine serviceability. L/E tips missing material.
Stage 11 Check Valves	Serviceable
Borescope Plugs (S7-1,7-2)	Serviceable

HPTN1 L/E.

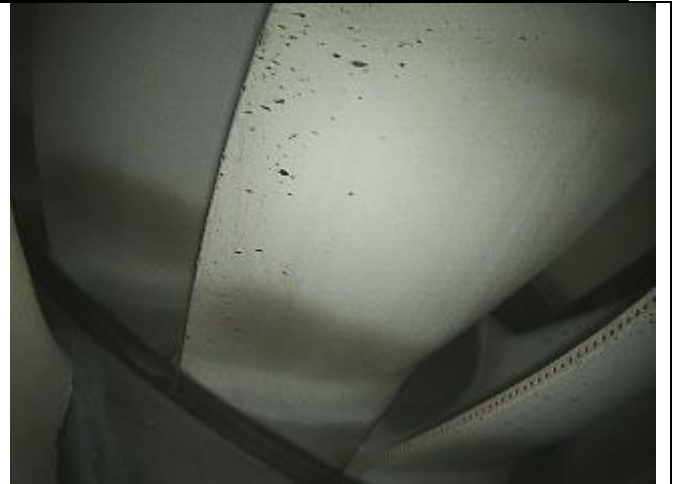
HPTR1 T/E Root.

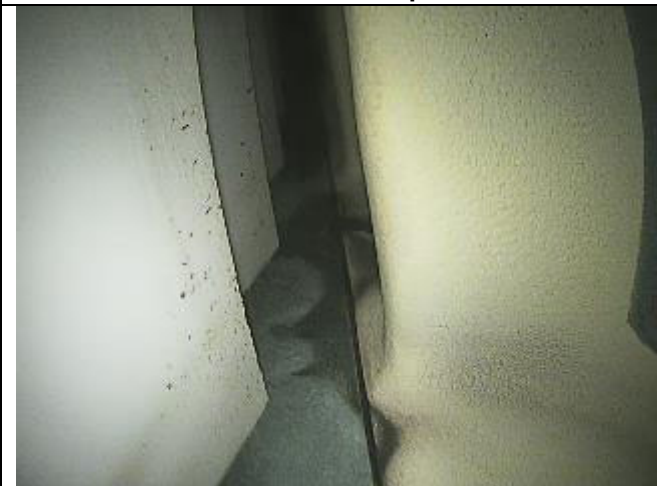
HPTN2 L/E. Outer Platform.

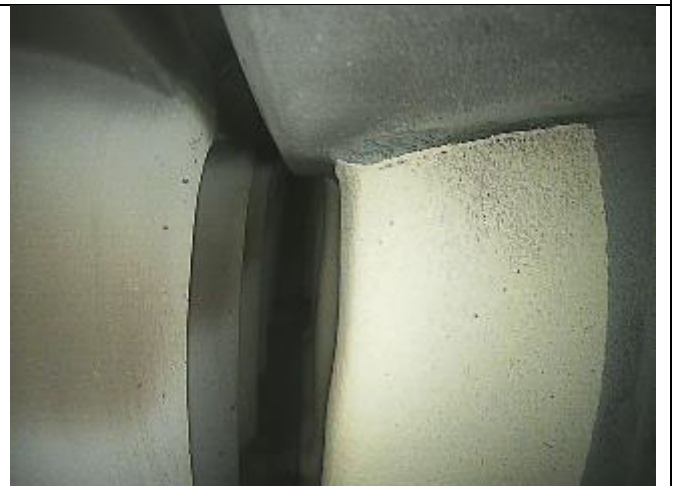
HPTN2 L/E. Inner Platform

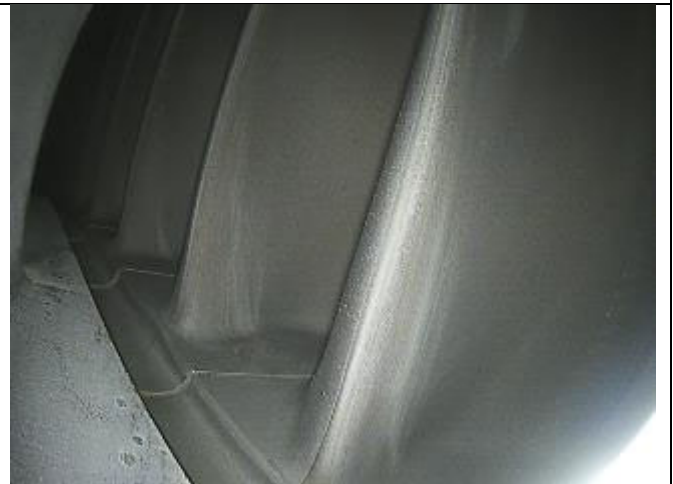
HPT2 L/E Root

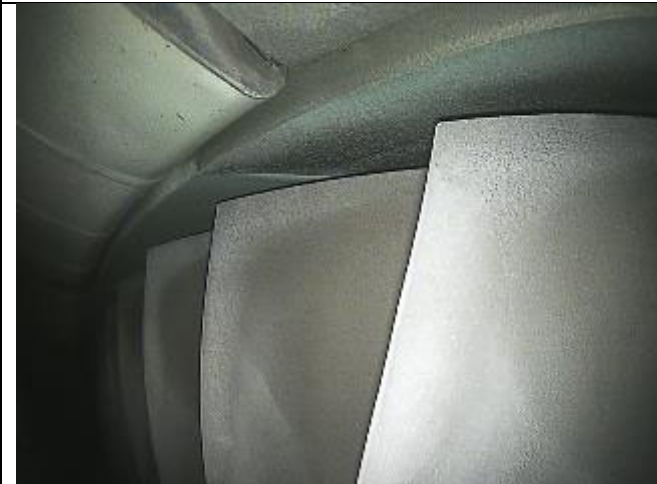
HPTR2 T/E Tip

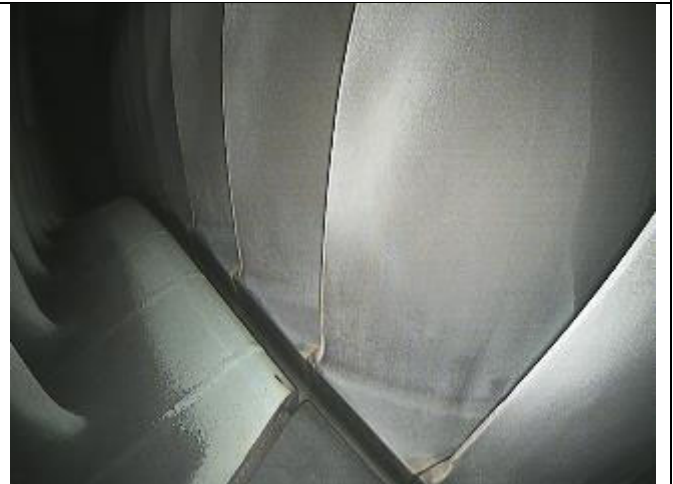
HPTR2 T/E Root

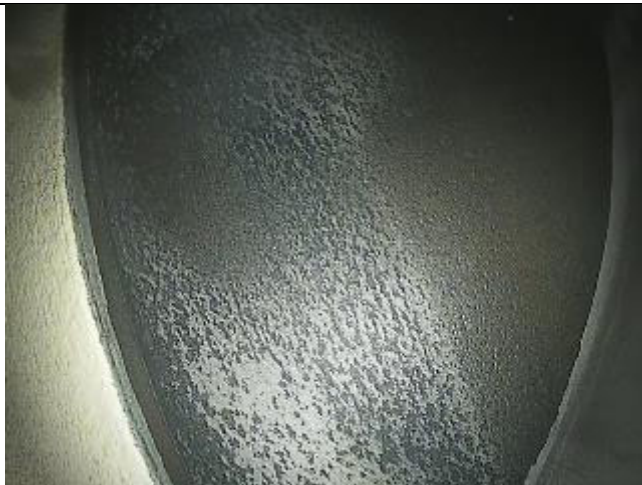
HPT Stage 2 Shroud.

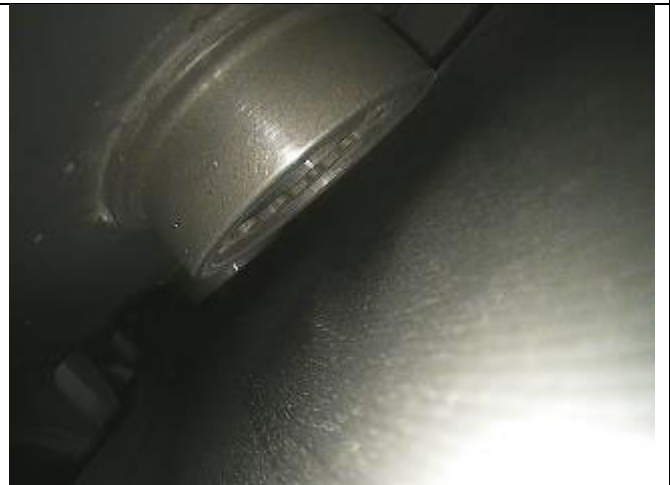
HPN2 Cooling air tube.

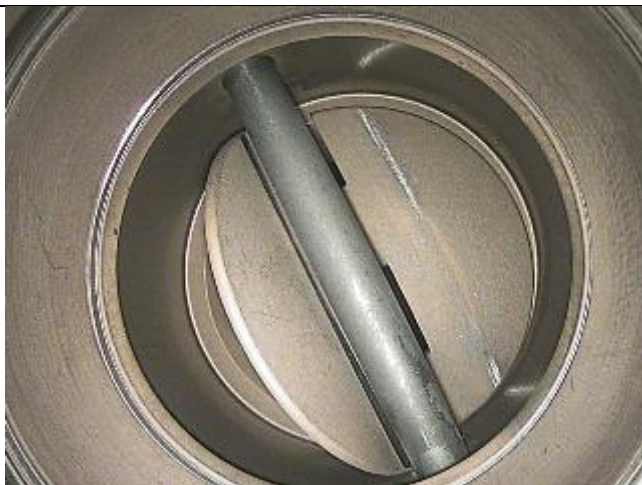
Stage 11 check valve

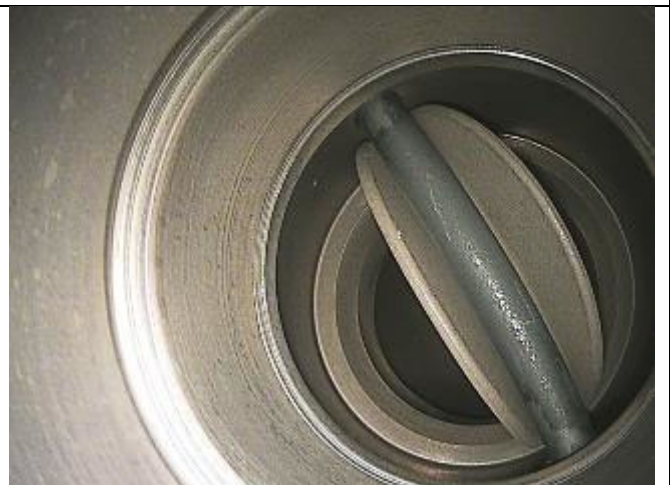
Stage 11 check valve

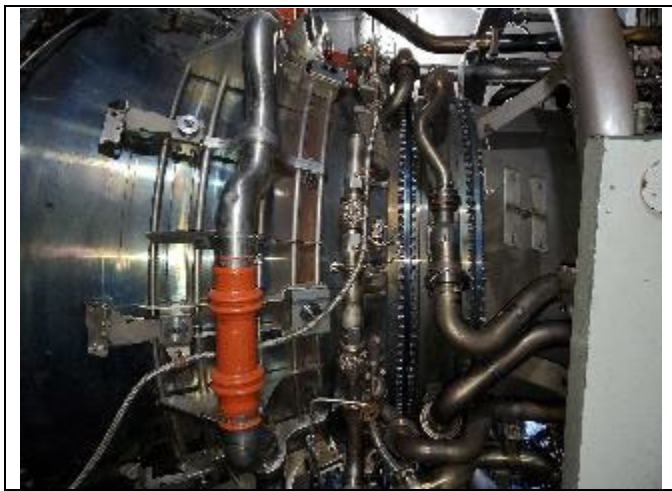
View of LPT R/S

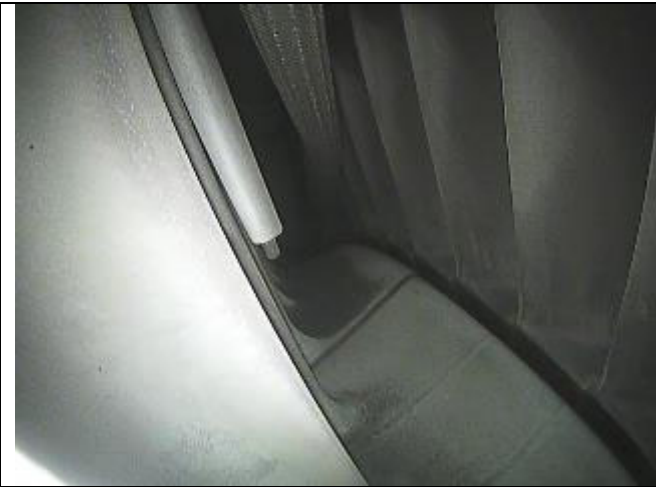
LPT Inspection Ports	S8-1 through S8-4
Nozzle Vanes	Serviceable
Rotor Blades	Serviceable
T4.8 Probes	Slight heat erosion evident, Serviceable
P4.8 Probe	Slight erosion evident, Serviceable
Additional Comments	IGB Splines clear, Serviceable. CRF clamps okay.

T48 Probe & LPT Stage 1 Nozzle L/E

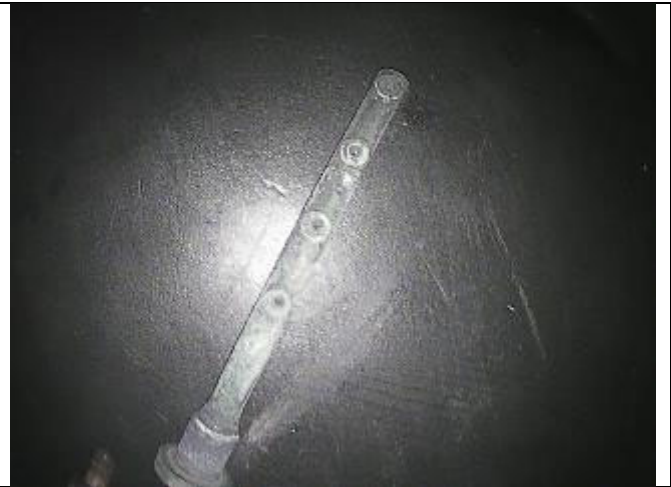
P48 Probe

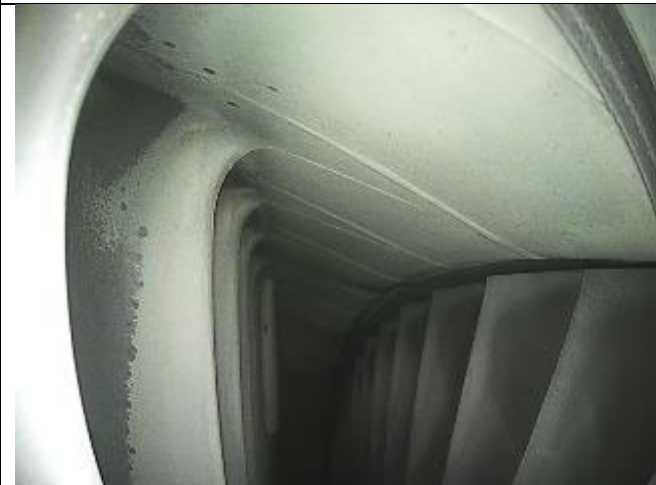
LPT Stage 1 Nozzle Outer Platform

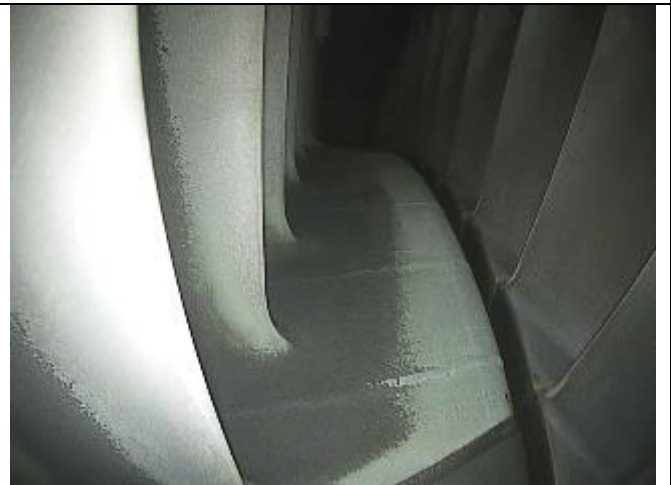
LPT Stage 1 Nozzle Inner Platform

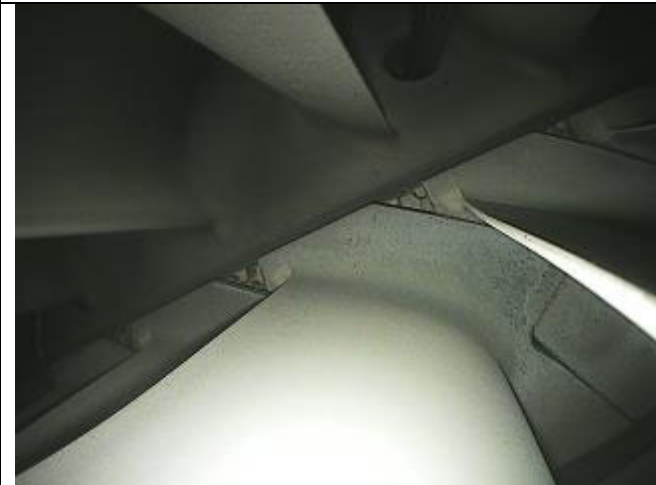
LPT Stage 1 T/E Outer Platform

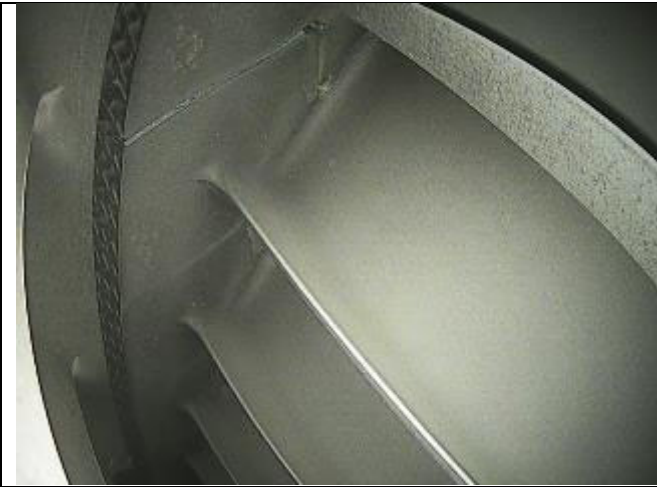
LPT Stage 2 L/E Outer Platform

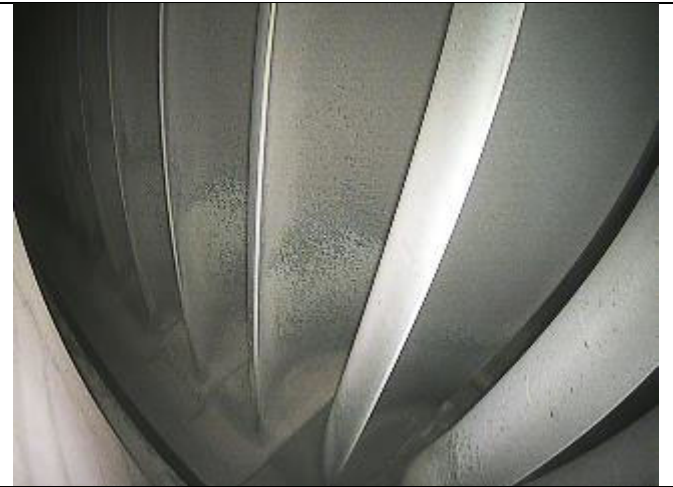
LPT Stage 2 L/E Inner Platform
